THE MITIGATION OF RADIO NOISE AND INTERFERENCE FROM ON-SITE SOURCES at RADIO RECEIVING SITES

November 2009

NAVAL POSTGRADUATE SCHOOL
Monterey, California 93943-5000

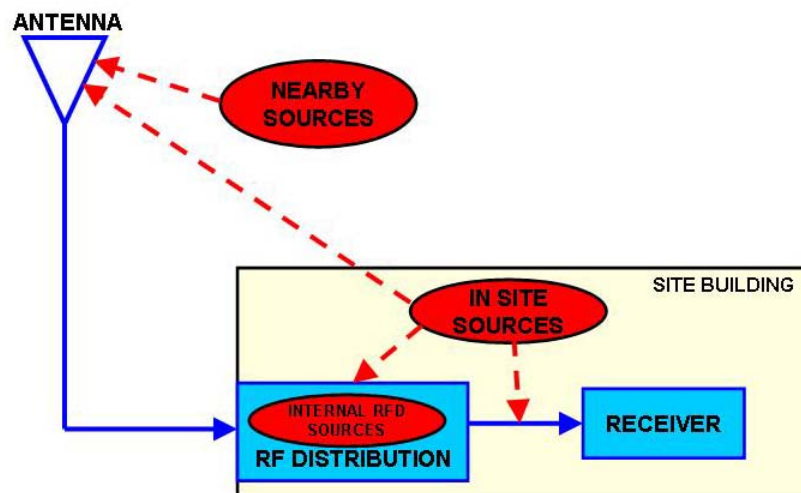
Many sites have outlying facilities which also contain sources of noise. These are shown by the red oval titled “Nearby Sources,” and noise from such sources can be received by the site’s antenna and be passed along to the input terminals of a receiver. Other sources can be inside the receiver building where it can leak into the RF paths by a variety of mechanisms. Still other sources of radio noise can be generated by filters, switches, amplifiers, and other components within the RF distribution system which are saturated thus generating intermodulation products and intermodulation noise.

Figure 1 Block Diagram of On-Site Sources

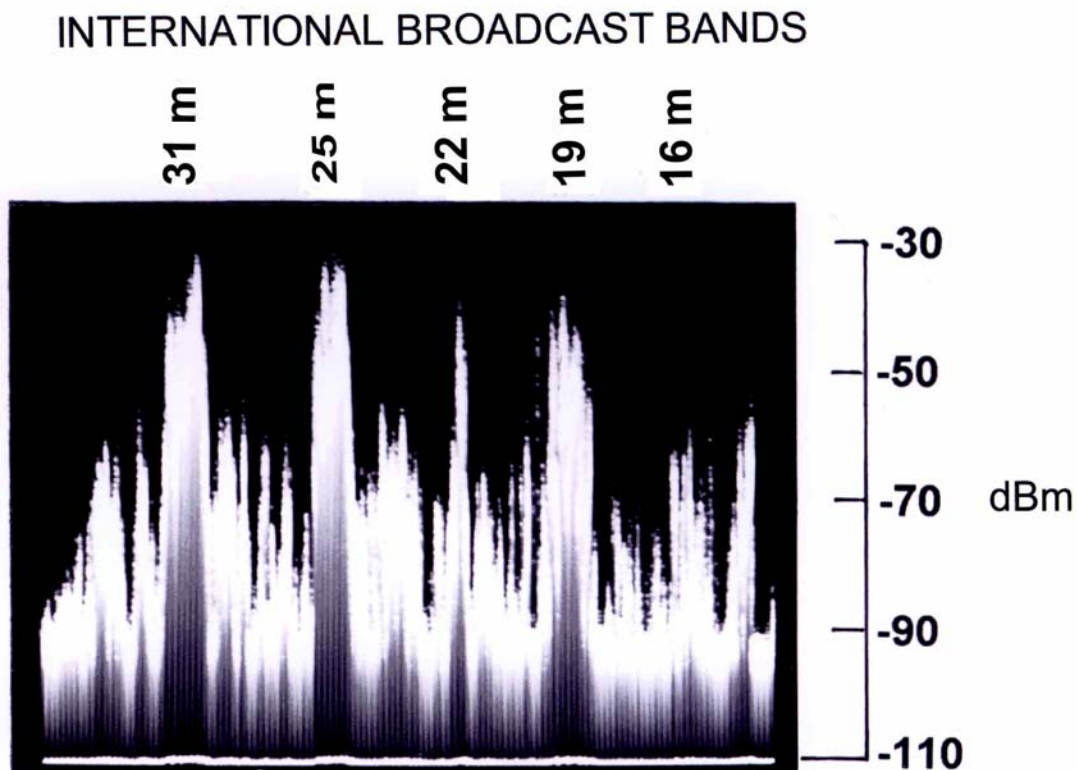
At nighttime when ionospheric absorption is low, HF signals will be 30- to 50-dB higher in amplitude than shown in Figure 2.

Figure 2 **Example of Daytime Signal Levels in the HF Band**

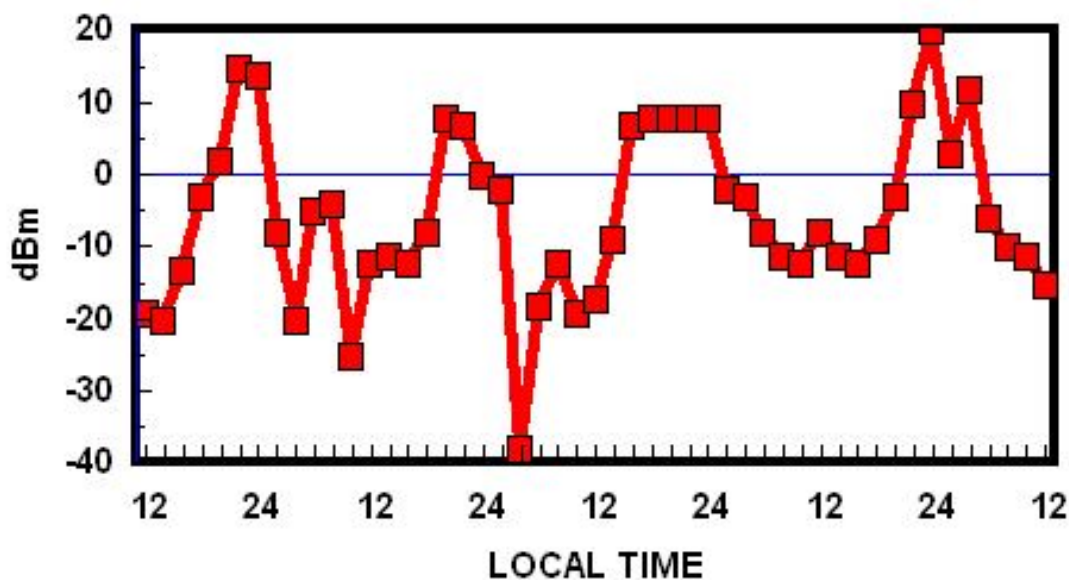
Figure 3 Diurnal Variations in Total HF Received Signal Power

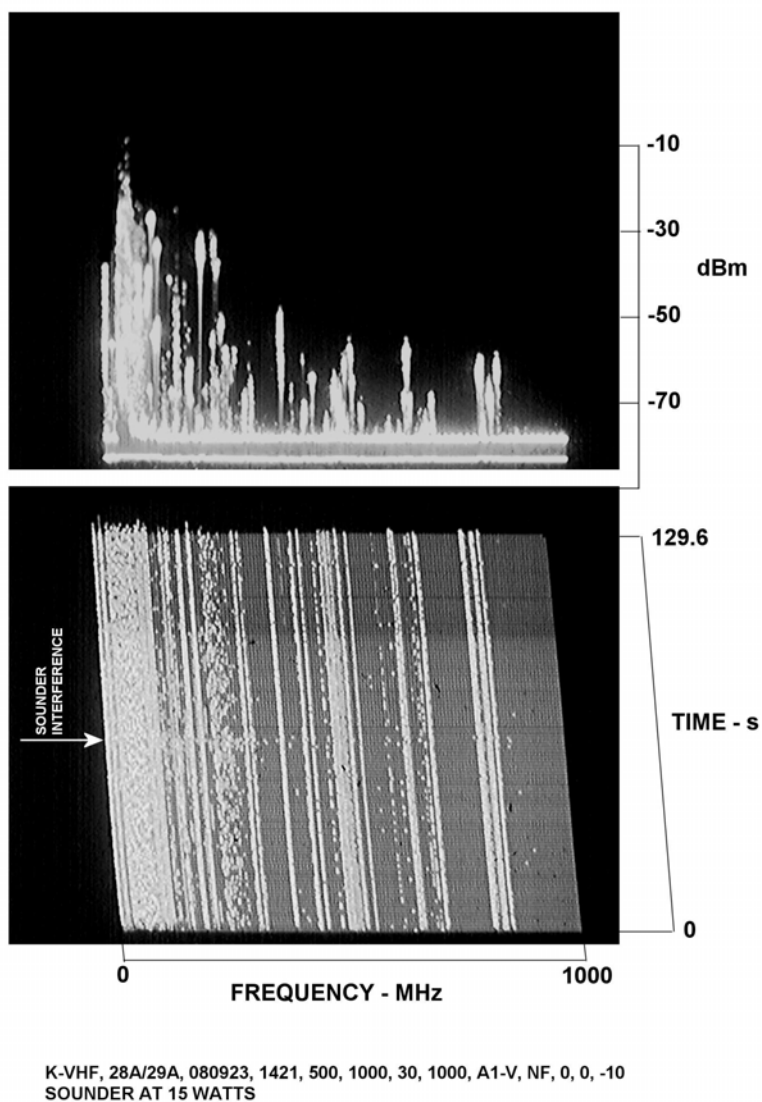
Figure 4 shows a typical example of signal levels in the VHF band. In this case the primary strong sources are FM and Television stations located on nearby hill or mountain tops that are within line of sight. Occasionally one will encounter strong signals from other nearby sources such as mobile or fixed communications sites.

Figure 4 Example of Strong Signals in the VHF Band

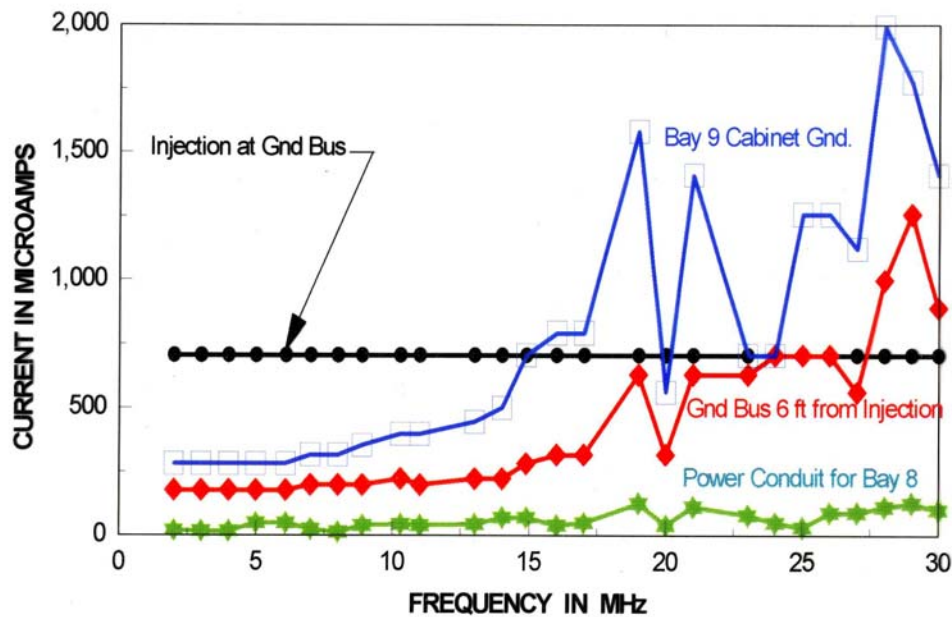
Figure 5 shows an example of standing waves along ground conductors for two equipment racks and along the conduit providing power to the racks. EMI current was injected into a ground bus at the power panel supplying power to equipment in the racks. Current was injected at a series of fixed frequencies and at a level of 750 μA rms. The injection level was set to the ambient broadband EMI current level flowing on the ground bus at a frequency of 2 MHz at this receiving site. The blue curve shows the measured current flowing in a ground bus at an equipment rack located about 10 feet from the injection point and as the injection frequency was varied. Peaks and nulls were found with frequency similar to the peaks and nulls found on a transmission line or an electrically long antenna. At the high-frequency end of the data, current peaks on the ground bus significantly exceeded the injection level.

Figure 5 Standing waves along Ground Conductors

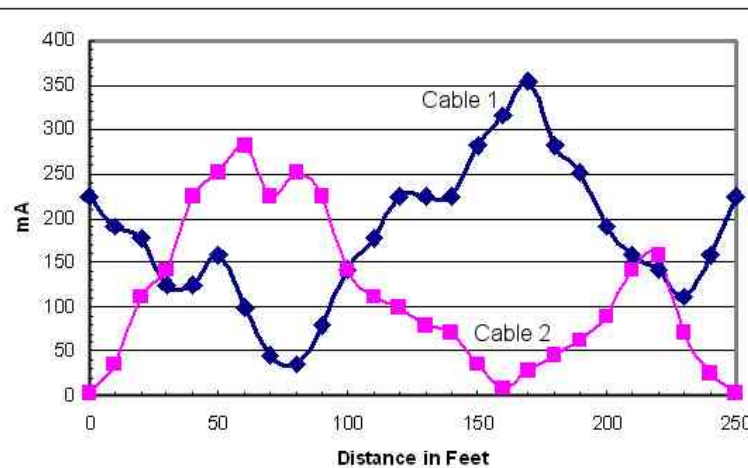
frequency of 2 MHz, and the shield current was measured at 10-foot intervals along the cable. The dark line on the plot of Figure 6 shows the current magnitude along the length of Cable 1. The distinctive standing waves on the cable shield are identical to those along a long-wire antenna.

Figure 6 Variation of EMI Current Level on Cable Shields with Distance

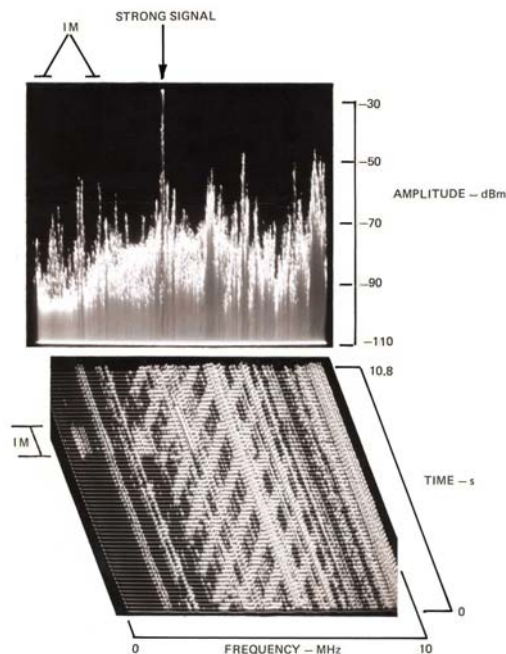
Figure 7 shows a brief burst of intermodulation noise caused by a strong signal burst that overloaded the amplifier of a multicoupler. Such bursts of IM noise can be similar to some short-duration signals, and when present they put an unwanted burden on a receiving system which must differentiate them from desired signals.

Figure 7 In-Band IM Noise

The previous Figure 7 shows one example where a strong signal about one-second in duration produced IM products and noise also about one-second in duration. Even shorter duration IM products and noise can occur, and Figure 9 shows an example. In this case a frequency-hopping transmitter emitting pulses in the low portion of the VHF band was operated adjacent to a receiving facility. Its strong VHF signals overloaded components in the RF path and produced high-level impulses of IM noise from 60 MHz up to 1000 MHz. Figure 8 shows an example of the resulting IM pulses in a 10-MHz wide portion of the radio spectrum centered at 309 MHz.

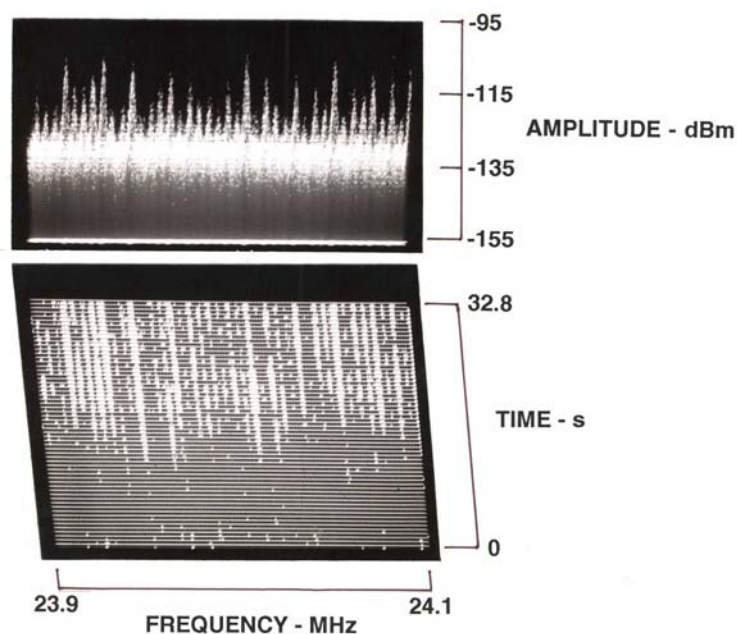
Figure 8 shows another example of interference caused by saturated components in an RF path to a receiver. Multiple high-level signals from international broadcast stations in the HF band exceeded the dynamic range of a component in the RF path and caused the closely-spaced IM products. In this case the broadcast signals were all below the frequency range shown. Ionospheric propagation limitations prevented normal signals from being received within the frequency range of the example at the time of day of the example, thus all of the spectral components in the view are IM products. The reduction in amplitude of the IM products in the lower one-third of the time-history view is because of fading of the ambient signals that overloaded the RF components. The maximum amplitude of the IM products is shown in the upper amplitude-vs.-frequency view. Additional IM products also existed at lower and higher frequencies, including the lower frequencies where the broadcast signals were received.

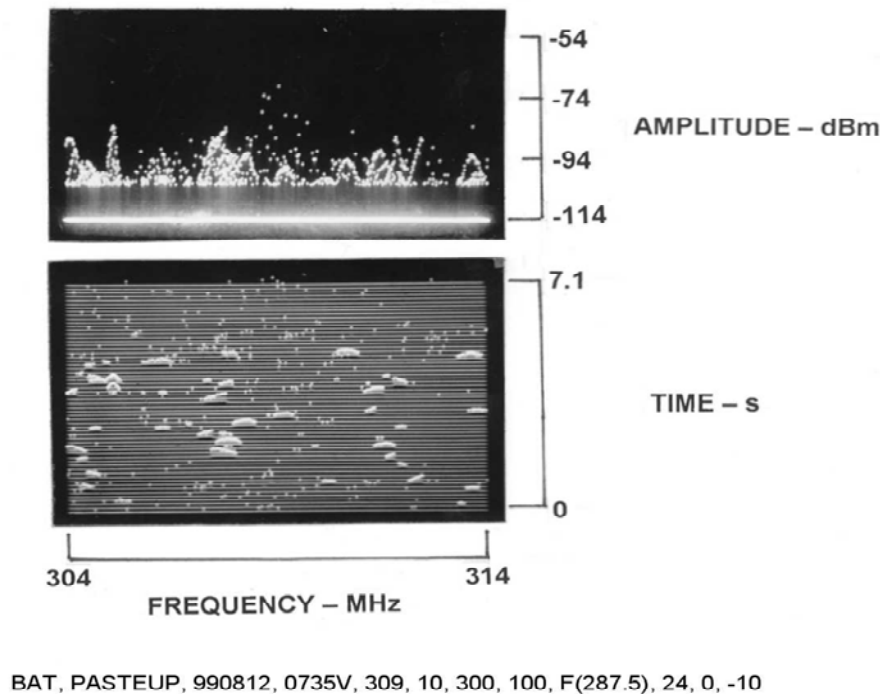
Figure 9 Intermodulation Pulses in the UHF band from a VHF Source

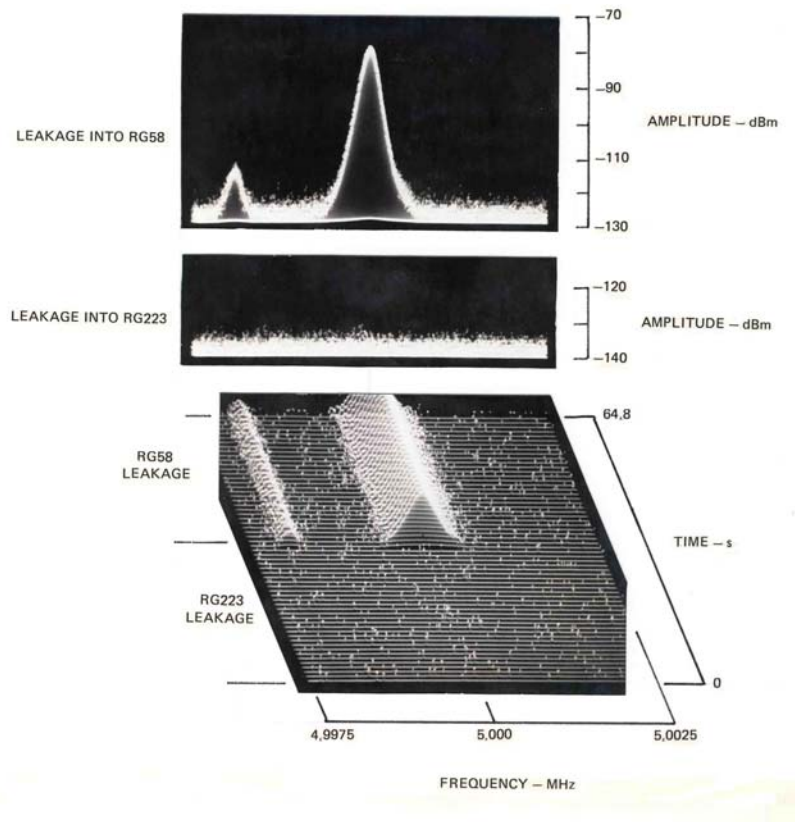
Figure 10 shows an example of severe leakage encountered at a receiving site. In this case a 5-MHz frequency-reference signal was distributed throughout the site over single-shielded RG-58 coaxial cable⁷. Radio signals were carried from the entry into the building and to receivers on single-shielded cables. Leakage of the reference signal and a second lower-level signal into a single-shielded cable feeding the receiver was exceptionally high. Of interest was that no detectable leakage was found in a parallel double-shielded coaxial cable feeding another receiver. This example clearly indicates that the use of single-shielded coaxial cable in a receiving site must be prohibited.

Figure 10 Example of Leakage into Coaxial Cables

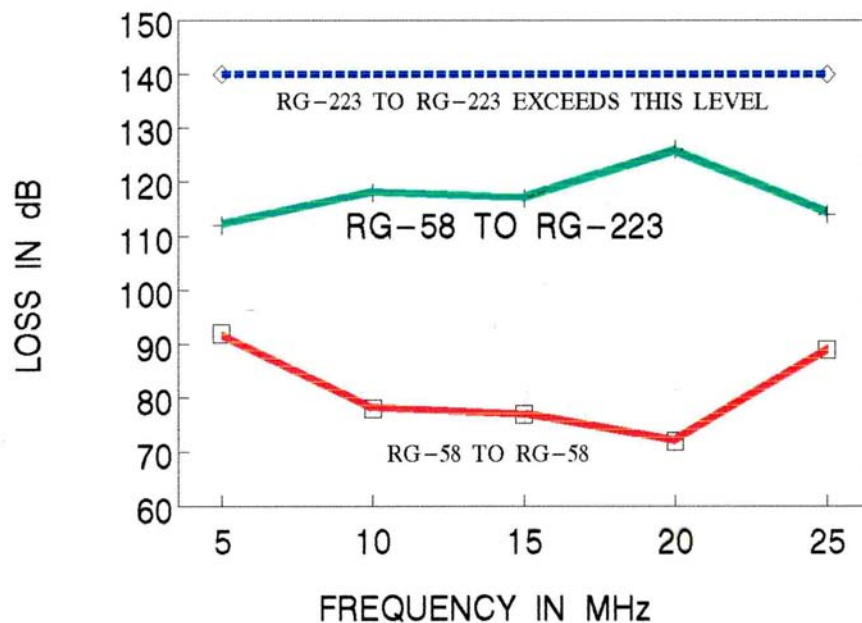
Figure 11 shows the result of this measurement where the leakage loss is expressed in dB. The single-shielded to single-shielded coaxial cable provided only about 70 dB of isolation near the center of the frequency range while the double-shielded to double-shielded loss was greater than 140 dB (not measurable with the test setup available). The single-shielded cable to single-shielded isolation is clearly insufficient to provide acceptable signal isolation from one antenna cable to another since at least 130 dB of cable-to-cable isolation is needed to avoid cross talk of received RF signals. The isolation provided by single-shielded to double-shielded cable also did not meet the needed isolation levels. Because of these findings only double-shielded coaxial cable should be used throughout a receiving site.

Figure 11 Cable-to-Cable Coupling Loss

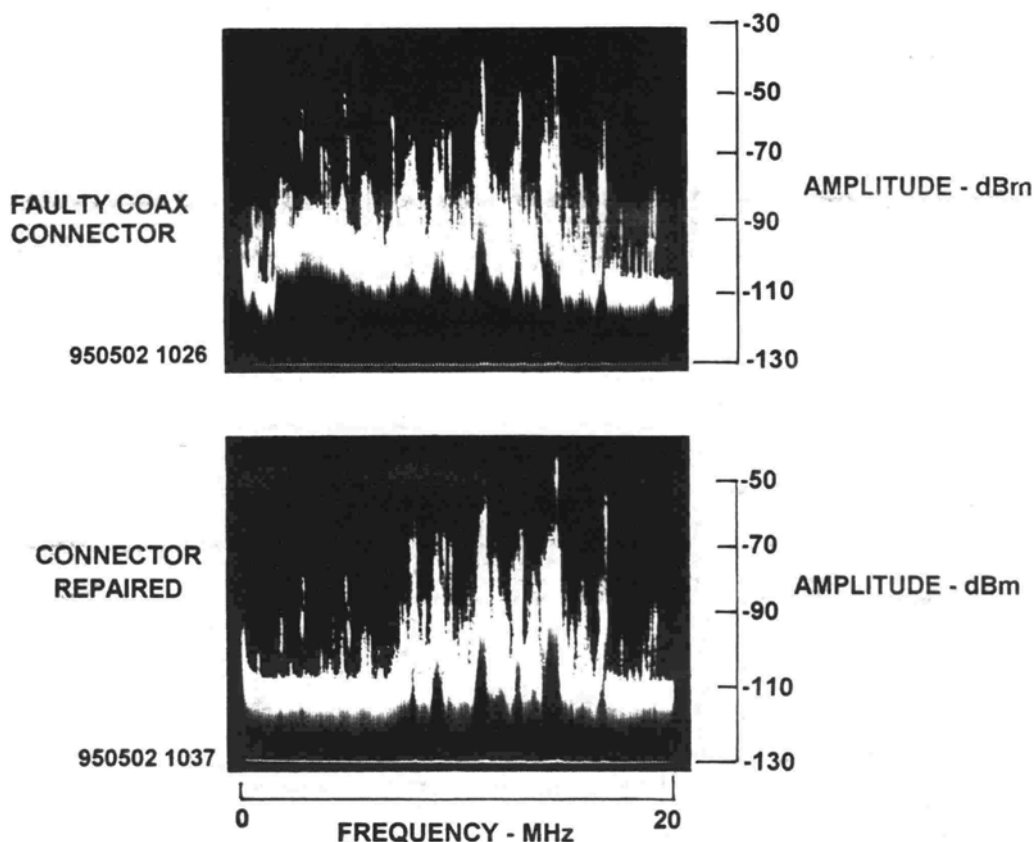
The upper view of Figure 12 shows signals and noise at the input terminals of a receiver when an improperly assembled coaxial connector was installed on a coaxial cable in the RF-Distribution path for that receiver. The shield of the cable was open at one end enabling EMI current and voltage on the cable shield to enter the signal path. The noise floor over the low-frequency portion of the frequency range is excessively high. The lower view shows the reduction in the noise floor when the shield was properly connected.

Figure 12 Impact of Improperly Assembled Coaxial Connector on Noise Level

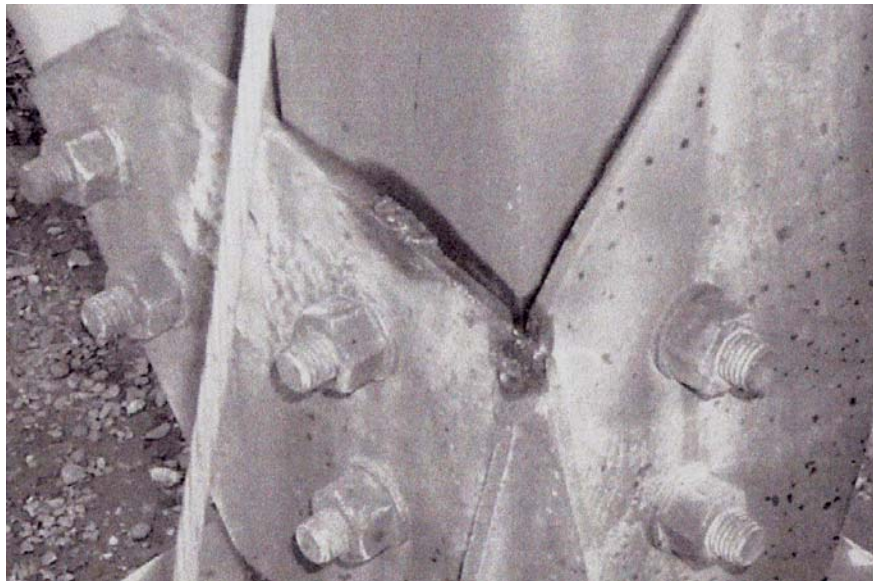
Figure 13 shows an example of a weld on a galvanized portion of an antenna tower at a receiving site. This tower was located on a hilltop receiving site in direct line of sight to television, FM, and AM broadcast transmitters as well as being close to other commercial and military communication sites. Such sources injected significant levels of current and voltage into the tower and its associated cable shields. If nonlinear joints are present on such structures, intermodulation products and broadband intermodulation noise sources will exist.

Figure 13 Weld on Galvanized Metal of a Receiving Antenna Tower

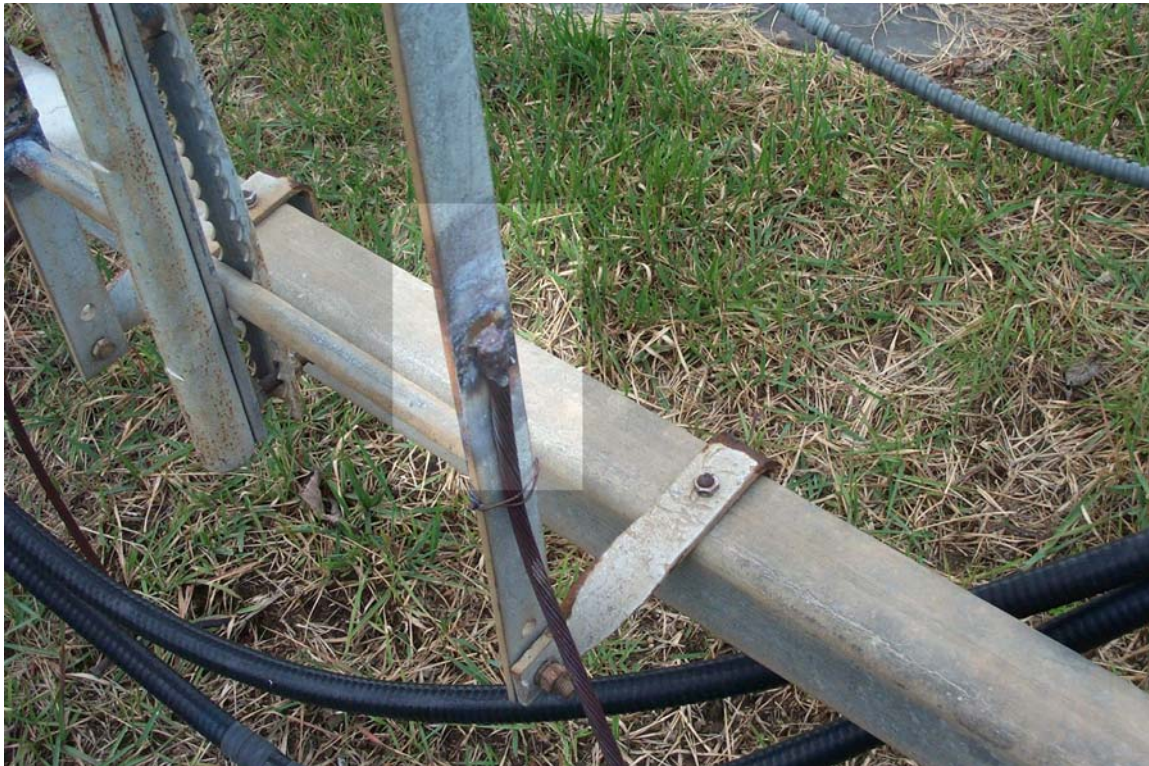
Figure 14 shows a ground conductor welded to a galvanized metal component of a tower at a receiving site. This tower was adjacent to the tower shown in the previous figure. The weld was clearly of poor quality, and it was necessary to use a tie wire to maintain its mechanical properties. In addition to its ability to produce intermodulation products and broadband intermodulation noise, the poorly welded joint would be blown free of the tower from surge current induced by a lightning strike.

Figure 14 Ground Wire Welded to Galvanized Metal on Antenna Tower

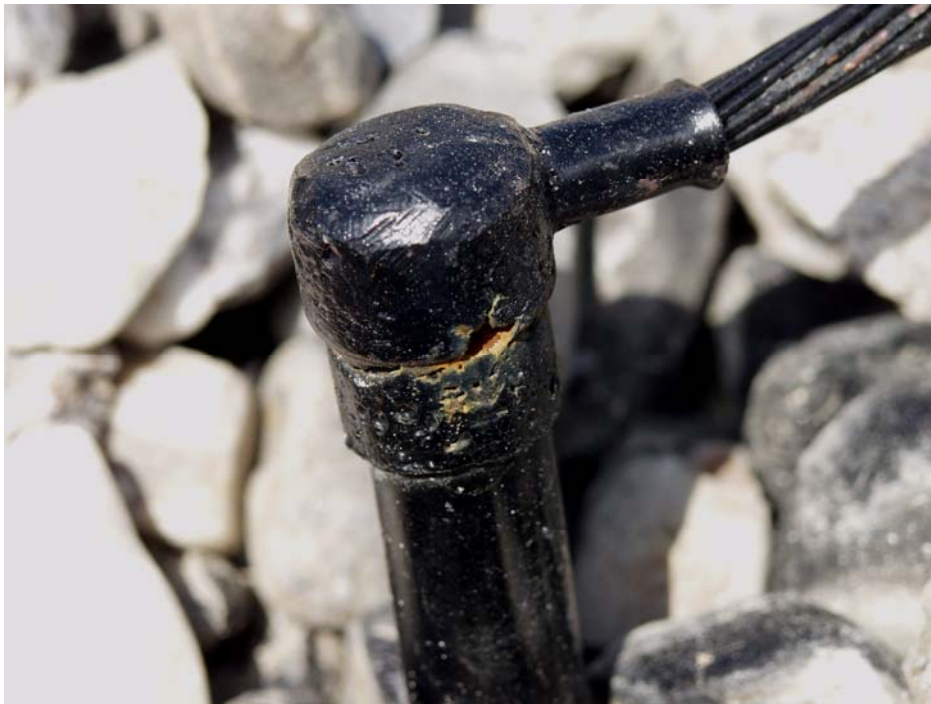
The use of mechanical electrical fittings fabricated of bronze will eliminate the possibility of these connections being sources of low-level intermodulation products and noise in the antenna counterpoise system. This will also eliminate the high levels of intermodulation when nearby radio transmitters are operated. CADWELD® joints should not be used on or near antenna fields or at any other location within or near a receiving site.

Figure 15 CADWELD® on Antenna Counterpoise Wire

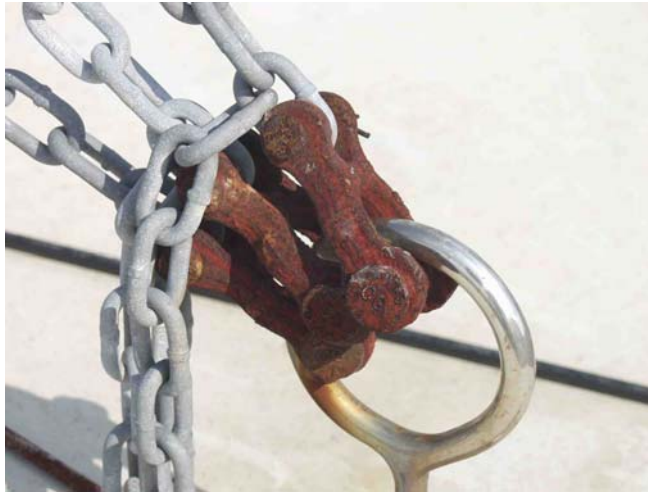
The rusty joint effect is well known to old-time radio engineers, especially when the rusty joint is in the antenna system. Figure 16 shows an example of such a joint that was part of an antenna guy. Also of concern is the use of chain in the guy because its joints can move from wind resulting in intermittent contacts. A thin layer of insulating oxide is formed on galvanized metal, and wear from movement can intermittently make and break through the layer. Non-conducting line should be used for all antenna guy material or metallic guys with properly installed and spaced compression insulators.

Figure 16 Example of a Rusty Joint

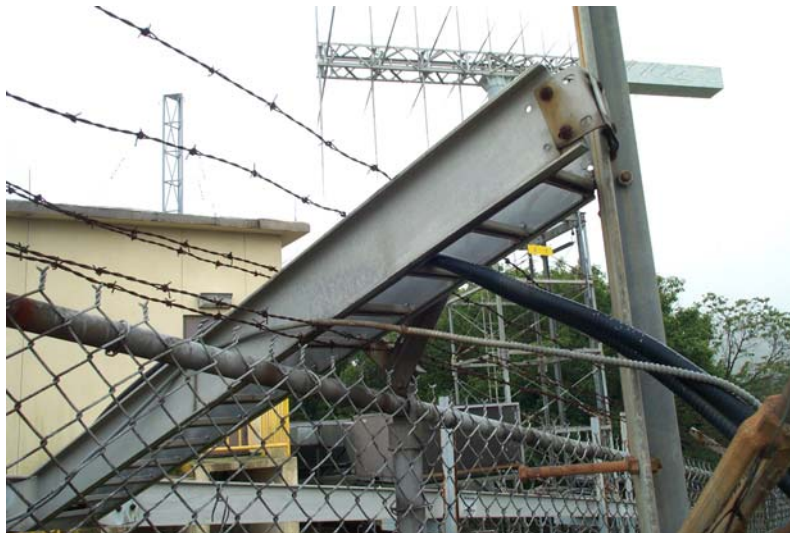
Figure 17 shows an example of multiple incidental contacts between conductors where the conductors are physically and electrically close to receiving antennas. Low-level standing waves of current and voltage exist on such conductors from ambient radio signals. The intermittent contacts formed by minor movement of the conductors result in impulses due to small potential differences between the conductors. These low level impulses radiate and result in low-level and erratic impulsive noise at the input of the site's receivers.

Figure 17 Example of Incidental Contacts

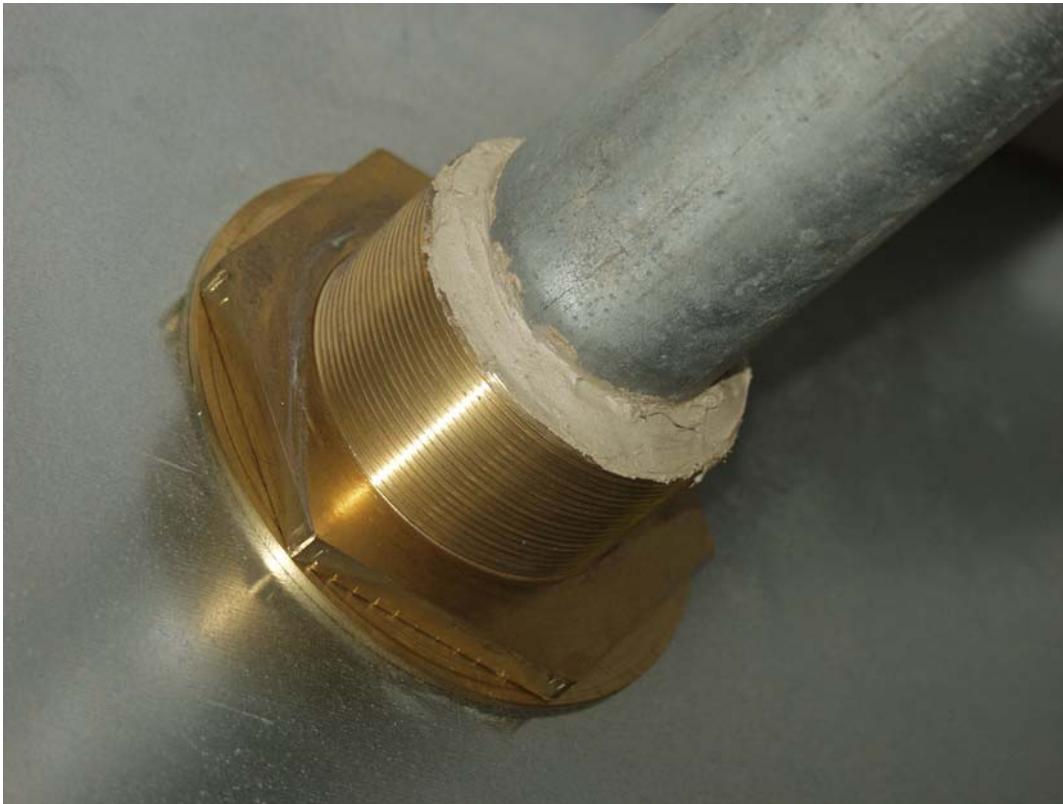
A few common examples of problems with shielded rooms are shown in this section. The technical details associated with the use of small and large shielded spaces are presented in more detail in Section 7. Figure 18 shows where a water pipe penetrated a wall of a shielded room. This pipe can conduct EMI current and voltage from outside sources into the room, and it can conduct EMI current and voltage from sources in the room to locations outside the room. The outside surface of the water pipe should be electrically connected to both sides of the shielded-room wall. This provides a low-impedance path for EMI current to flow back to its source rather than into or out of the shielded room.

Figure 18 Water Pipe Penetrating a Shielded Room

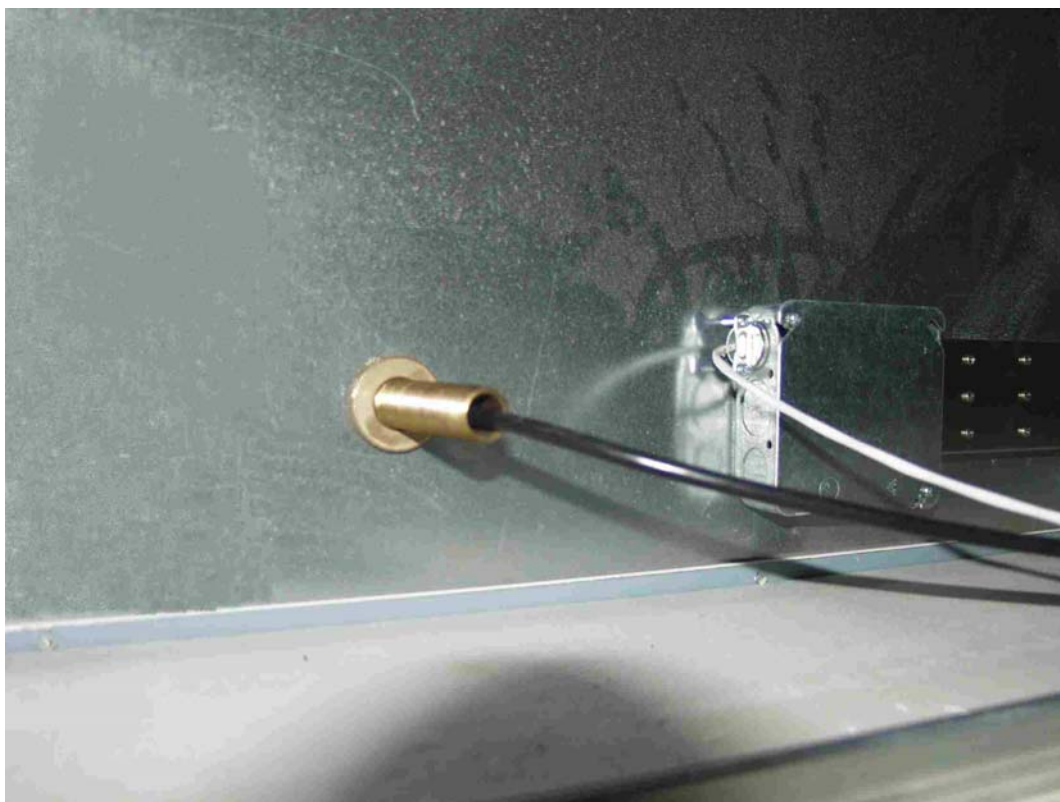
Figure 19 shows another penetration of a shielded room. In this case a coaxial cable associated with the site's security system penetrated the shielded room. Its shield carried EMI current and voltage into and out of the shielded room. This kind of conducting penetration must be avoided since a single such penetration as shown can completely destroy the effectiveness of a shielded room. In this case a standard coaxial bulkhead connector at the penetration point would have provided a satisfactory means of terminating the cable shield on both sides of the wall of the shielded room.

Figure 19 Coaxial Cable Penetration of a Shielded Room

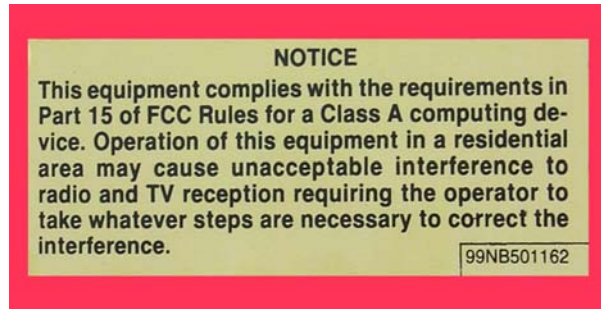
Figure 20 Radio-Interference Label from a Class A Device

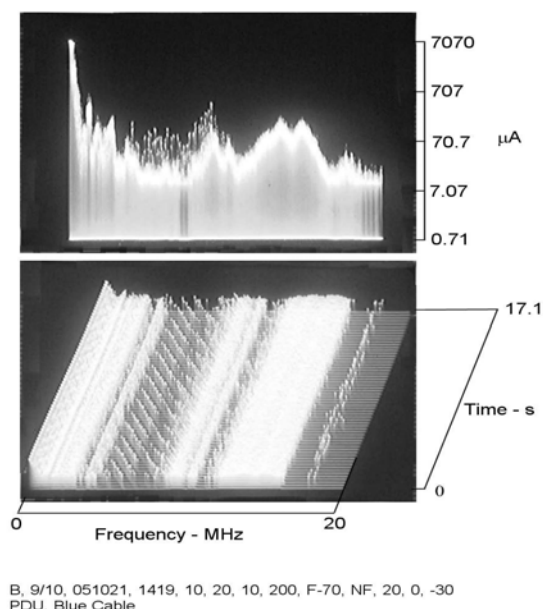
A few examples of excessive EMI current flowing on cables in a receiving site will demonstrate the problem. Figure 21 shows EMI current flowing on one of the 3-phase output power conductors of a Power Distribution Unit (PDU) over the frequency range of 100 kHz up to 10 MHz. This particular PDU was located within a shielded room that housed the RF-distribution equipment for an HF receiving site. The PDU contained a switching power supply for its electronics along with other digital control devices, and it provided electric power to all equipment located within the shielded room.

Figure 21 EMI Current Flowing on PDU Power Conductor

Severe peaks and nulls in noise amplitude were found across the entire frequency range of the data at levels significantly above the minimum tolerable level provided in Table 1. The slanting lines in the time-history view over the frequency range of about 3.5 to 8 MHz are from repetitive impulsive noise with a period of 8.3 ms (a pulse occurrence rate of 120 per second). The amplitude of these impulses is shown in the upper amplitude-vs.-frequency view. The noise in the remaining part of the HF band was a combination of impulsive noise at lower levels and closely-spaced spectral components related to harmonics of the power-line frequency and of the switching rate of the power-converter device.

The PDU was examined to determine if it was procured in accordance with the FCC Class B noise voltage rating. No label was found on the unit, a violation of the FCC rules. While the voltage level of noise was not measured in accordance with the FCC test procedures, the high noise current level clearly indicate this unit was either manufactured to the FCC Class A industrial noise requirement or the noise requirement was simply ignored.

An examination of the power-conversion devices contributing to the harmful levels of radio noise in Figures 21, 22 and 23 did not reveal the expected Class B or Class A labels required by the FCC for such devices marketed for general sale. Additional examination and measurements indicated that all were intended for industrial use rather than meeting the FCC Class B requirement for residential use. The use of such devices in and near a radio receiving site can significantly degrade the ability of a site to receive low-level radio signals of special interest, and they should not be installed in such facilities.

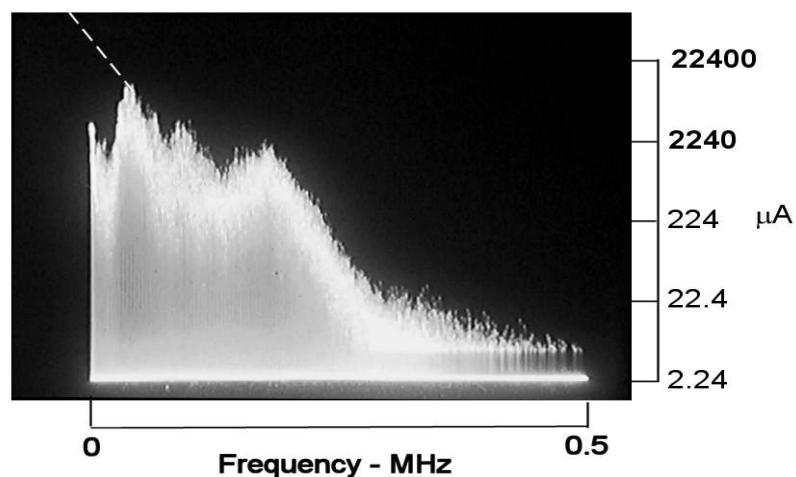
Figure 22 shows noise on one of the 3-phase conductors feeding power into the shielded room. In this case the power is provided to a 30-kVA UPS located in an adjacent shielded room, and it passed through a large low-pass filter located on the UPS side of the wall of the shield separating the two rooms. The drop in noise amplitude above about 200 kHz is caused by the filter. Note that the noise level at 500 kHz is very low, and the device met the requirements of Table 1 for a large site at all frequencies above about 1 MHz. The filter installation was effective at the higher frequencies, but excessive levels of noise and harmonic components of the power-line frequency and the switching rate of the UPS exceeded the low-frequency level stated in Table 1.

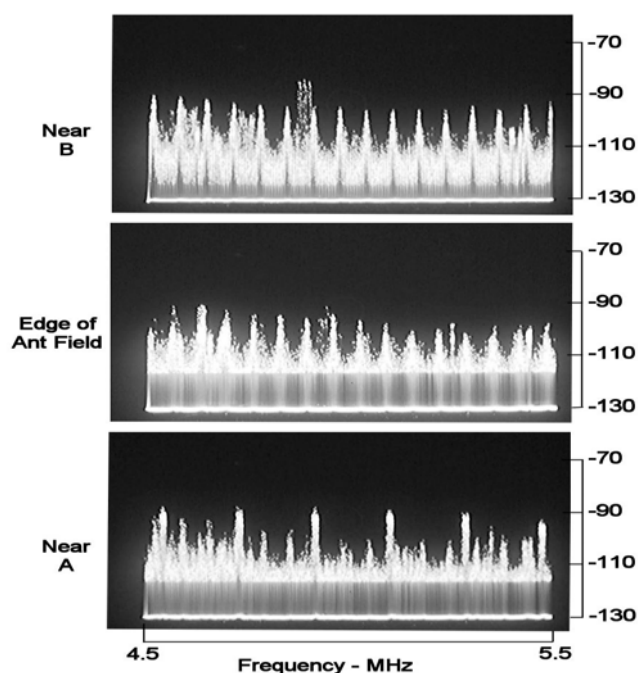
Figure 23 shows the amplitude of spectral components of noise collected by the test dipole antenna over the frequency range of 4.5 to 5.5 MHz at three locations. The top location was near the center of the antenna field, the middle location was near the edge of the antenna field, and the bottom location was near a nearby large facility. The data clearly show that excessive spectral components of noise were injected into the test antenna and also into the site's antenna counterpoise wires from EMI current flowing on the underground cables.

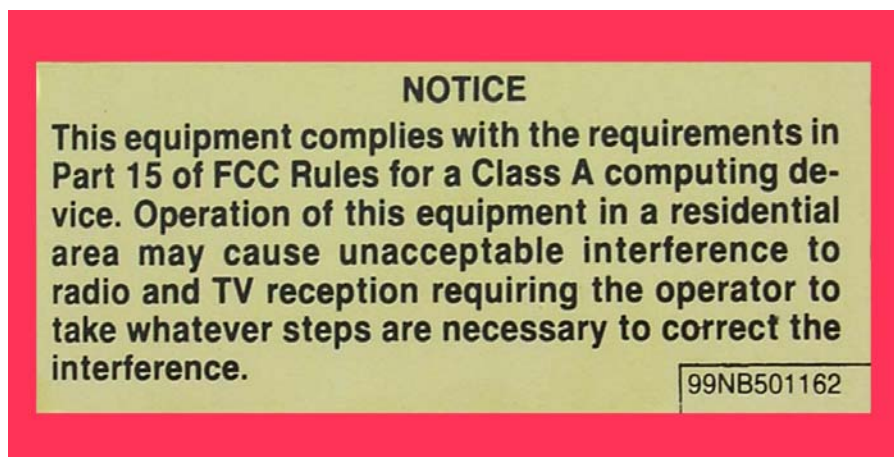
Figure 24 Example of FCC Class A Label

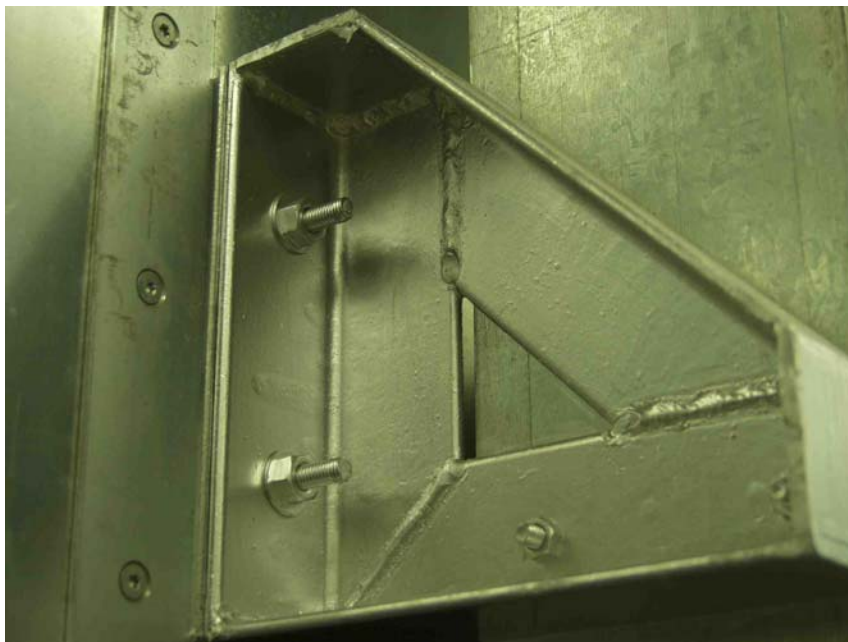
In addition to the above items, other building issues that impact the operation of a radio receiving site can exist. Figure 25 shows a support bracket fabricated out of galvanized steel and bolted to the side of a shielded room. This bracket was welded after galvanizing. While it provided excellent mechanical support, EMI current was flowing on the surface of the shielded room and such current passed through the nonlinear joints of the welds. The resulting harmonics, IM products and IM noise generated by the nonlinear joints added significantly to the RF environment inside the room which contained RF cables, RF preamplifiers and other low-level radio systems.

Figure 25 Weld on Galvanized Steel inside a Radio-Receiving Building

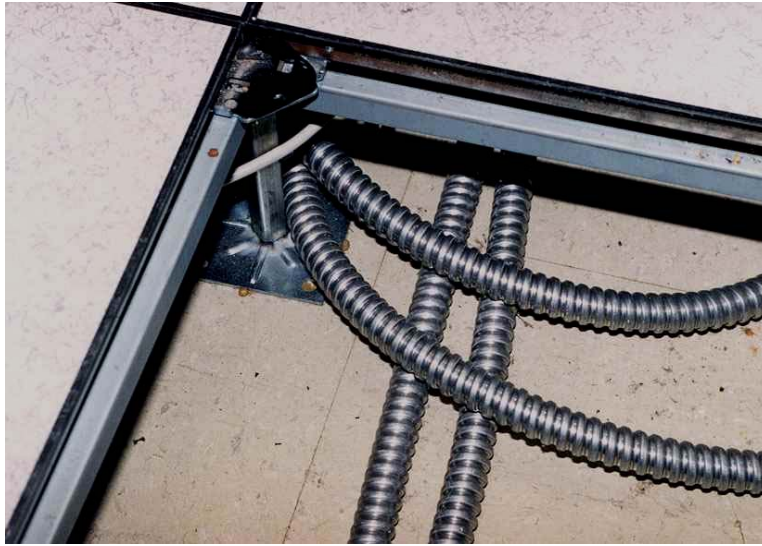
Figure 26 shows a photograph of unwanted intermittent contacts. MC cables providing power to electronic devices were in loose contact with each other. Also two of the cables were in intermittent contact with a metal floor stanchion. Unfortunately, the MC cable shields carried significant levels of current at harmonics of the electric power, and a person walking on the floor above can cause sufficient movement to produce harmful levels of transients.

Figure 26 Incidental Contact, Example 1

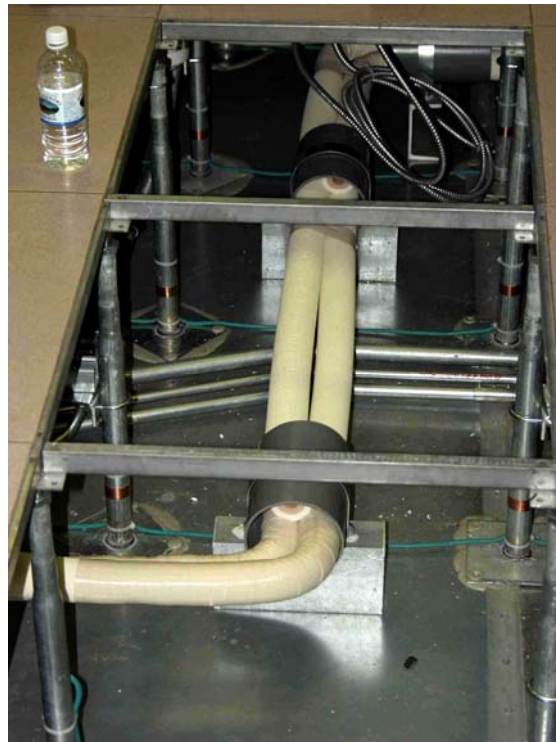
Still another example of incidental contacts between conductors is shown in Figure 27. In this case an extra length of MC cable was coiled and left under the floor in loose contact with other conductors. It also resulted in unwanted transients when anyone walked on the floor above the cable. Of interest is that the photograph shows that other metal objects were properly bonded together to avoid the production of transients.

Figure 27 Incidental Contact, Example 2

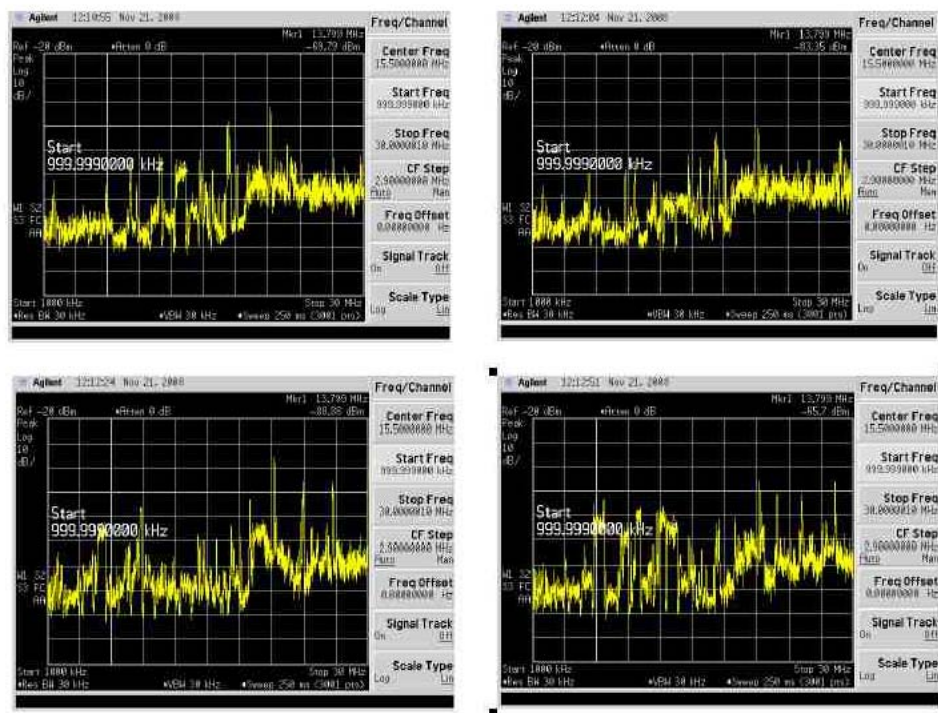
Figure 30 shows an example of erratic noise and interference found over the 1- to 20-MHz portion of the HF band at a receiving site where the data was obtained with a conventional scanning spectrum analyzer. Four sequential scans are shown where the spacing between the first two scans is about 20 seconds, and the spacing between the other examples is only a few seconds. A careful examination of the four examples shows significant differences in detail from one to the next one. The spectral and temporal properties of the noise and interference changed significantly from example to

example, and the changes cannot be understood from such sequential examples. These examples illustrate the difficulty in describing erratic noise and interference with standard instruments.

Figure 30 Example of Erratic Noise and Interference

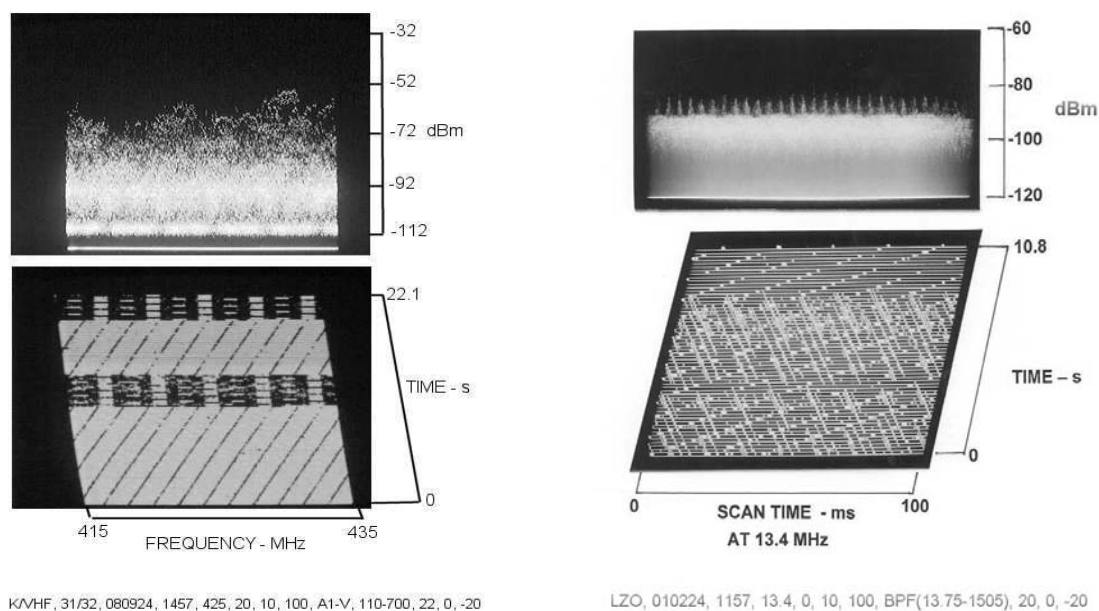
In both examples, the interference extended well above and below the frequency ranges shown.

Figure 31 Severe Radio Interference from Variable-Speed Electric-Motor Drives

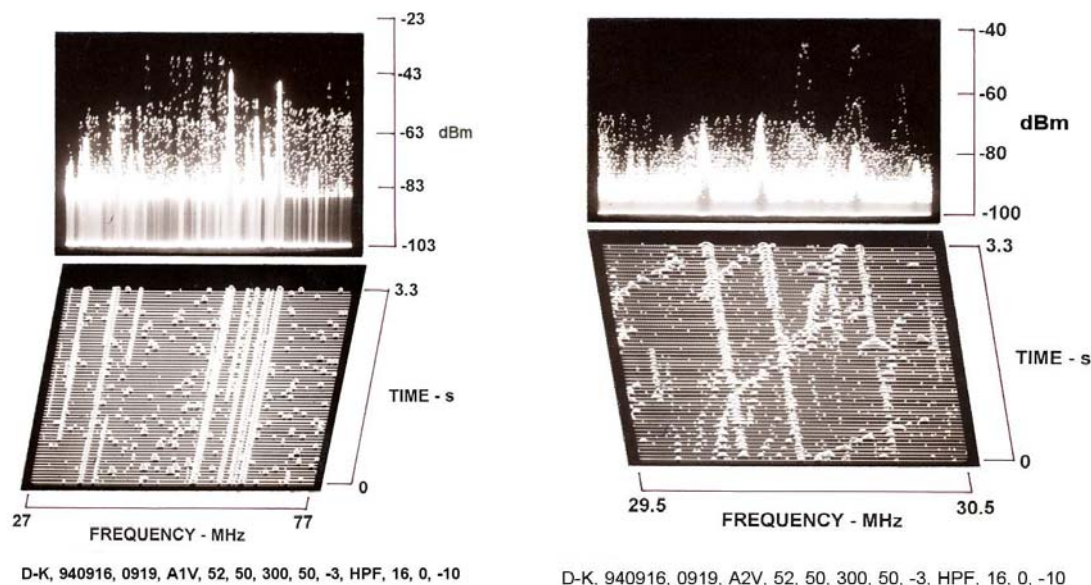
The right view shows variable-frequency emissions causing intermittent interference to an HF receiver. In this case, multiple emissions from the radio-frequency heaters of multiple plastic molding machines caused the intermittent interference. Such emissions are permitted for the Industrial, Scientific and Medical (ISM) radio service within the band of $27.120 \text{ MHz} \pm 160 \text{ kHz}$. The emissions originated from a factory located more than 10 km from the receiving site, and the emissions are clearly outside their allocated frequency band.

Figure 32 Intermittent Interference from Frequency-Hopping and ISM Emissions

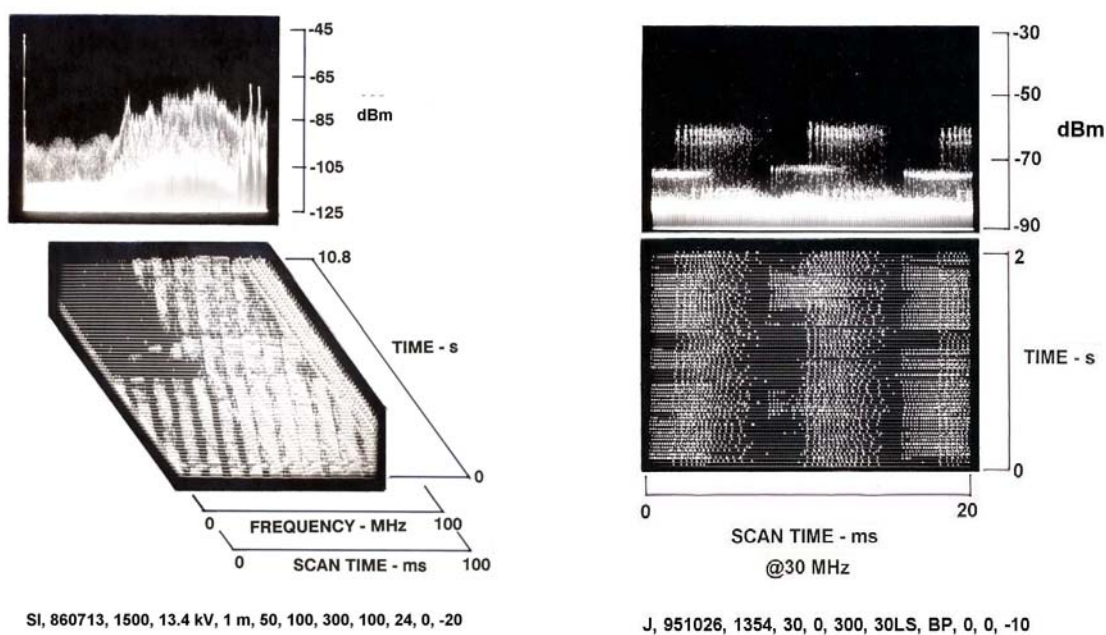
Figure 33 The Complex Structure of Intermittent Power Line Interference
