THE MITIGATION OF RADIO NOISE AND INTERFERENCE FROM ON-SITE SOURCES at RADIO RECEIVING SITES

November 2009

NAVAL POSTGRADUATE SCHOOL
Monterey, California 93943-5000

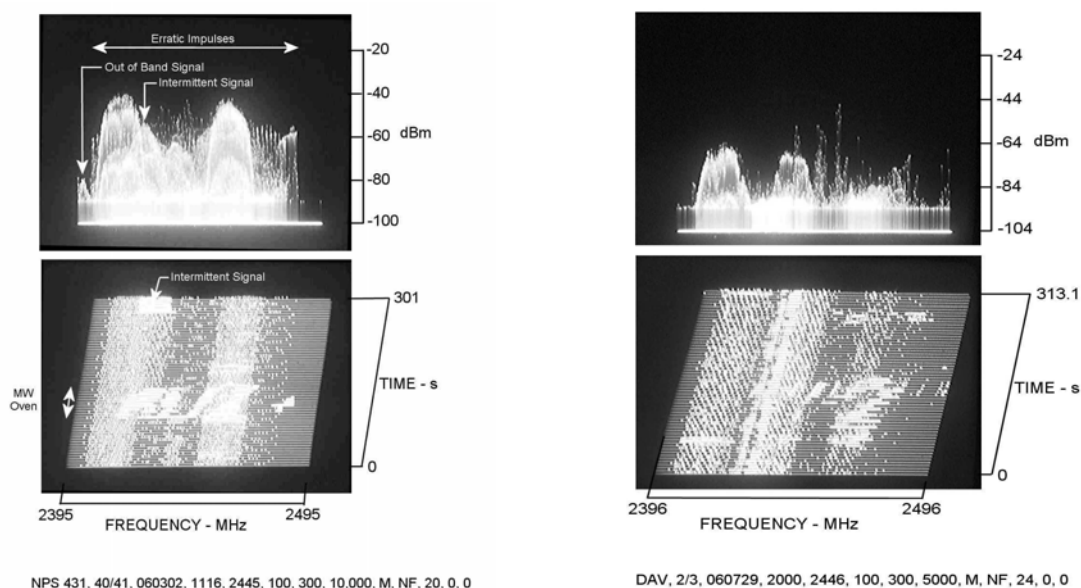
Figure 34 Signals and Interference in the 2.4-GHz Wireless Band

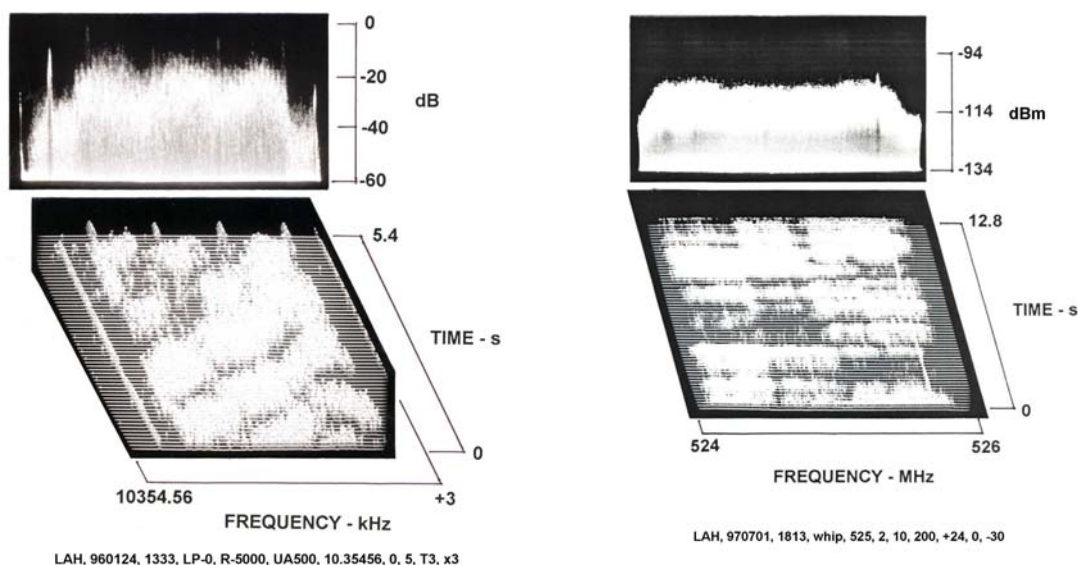
Figure 35 Erratic Signals

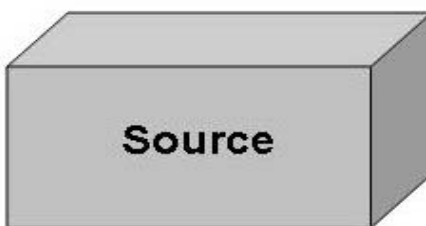
Figure 36 Source Enclosed within an Electromagnetic Barrier

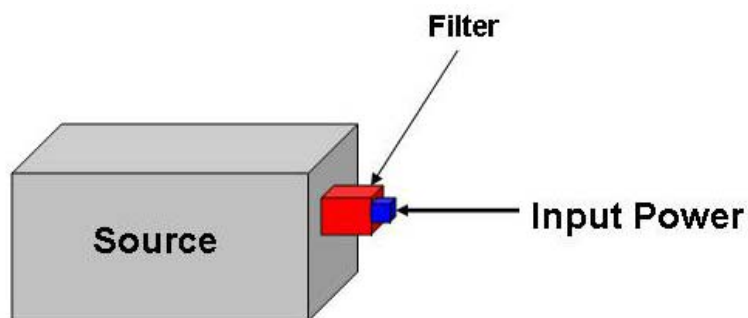
Figure 37 Provision of Power to a Source

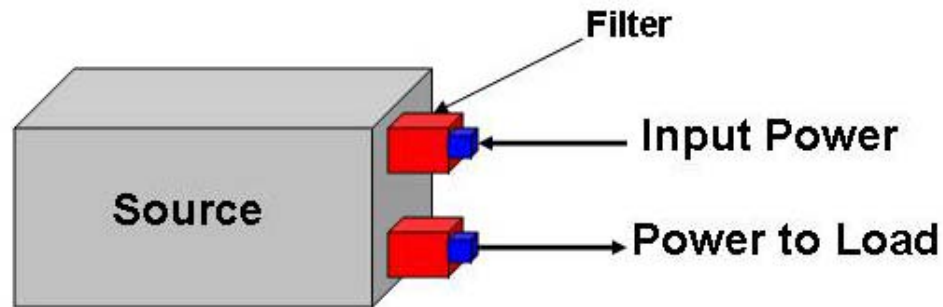
Figure 38 Provision of Power to a Load

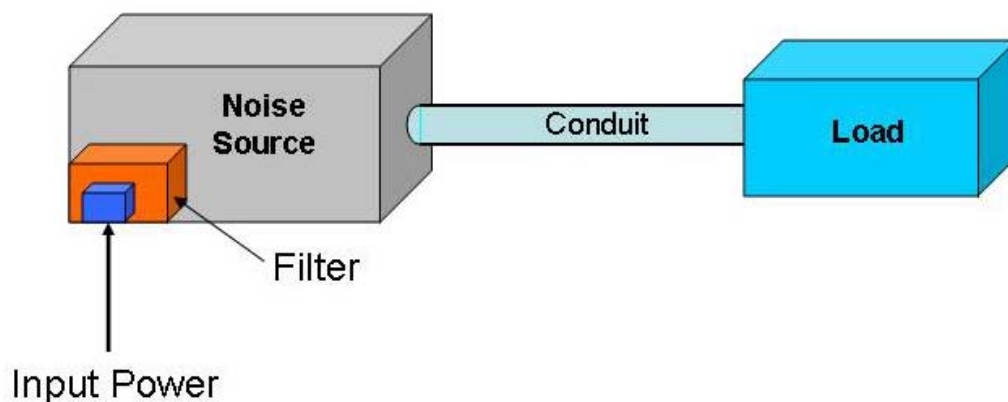
Figure 39 Source-to-Load Connection

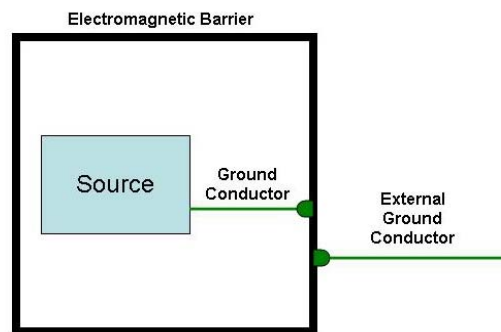
Figure 40 Barrier Treatment of a Ground Conductor

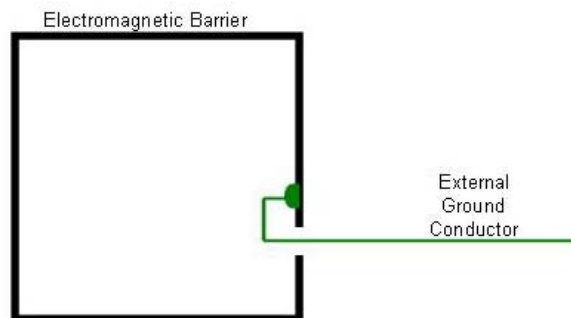
Figure 41 Improper and Ineffective Treatment of a Ground Conductor

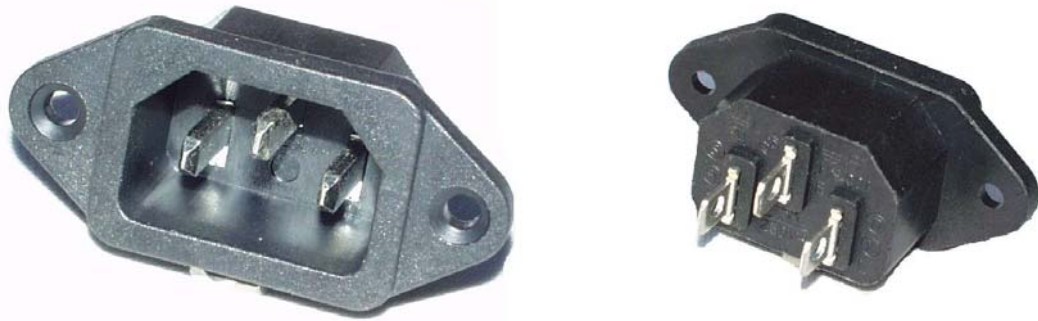
Figure 42 Chassis Power Connector that does not comply with BFG Needs

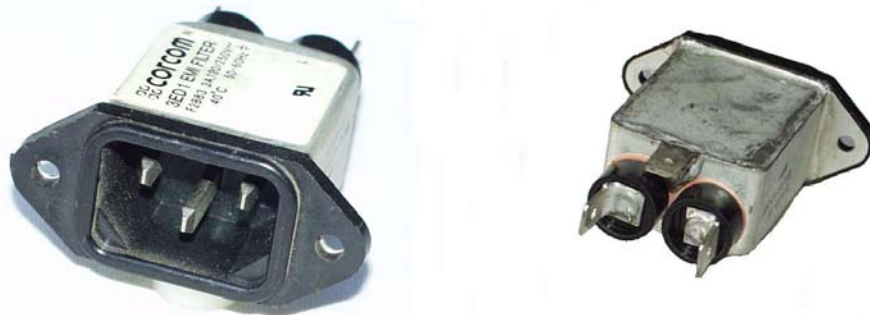
Figure 43 Chassis Power Connector that meets BFG Needs

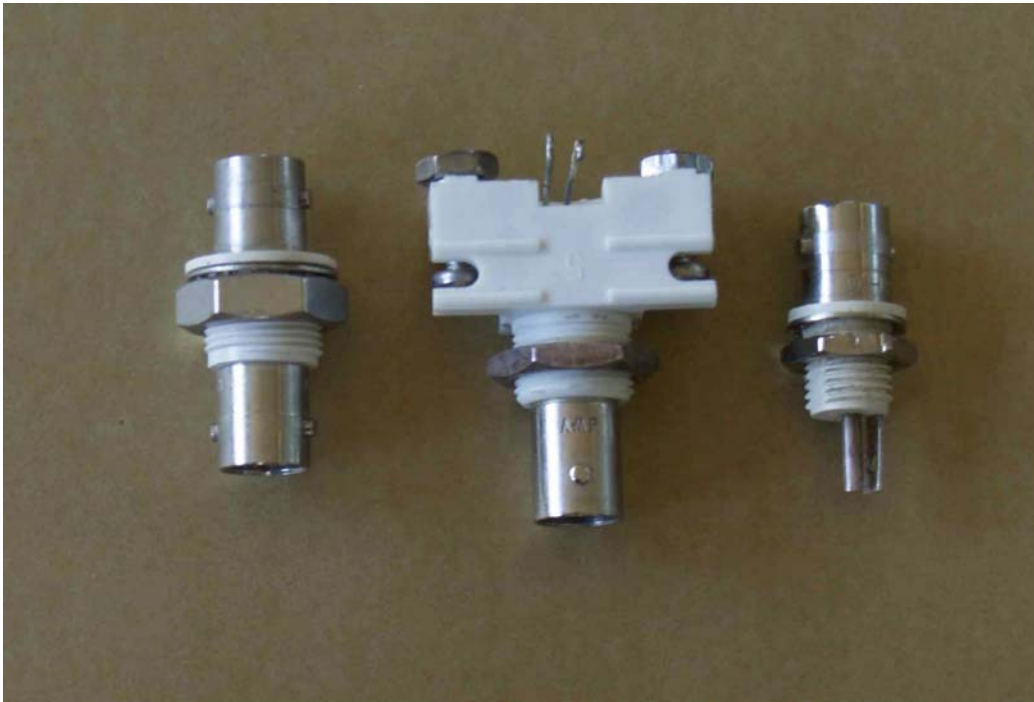
Figure 44 Examples of Insulated Bulkhead Connectors

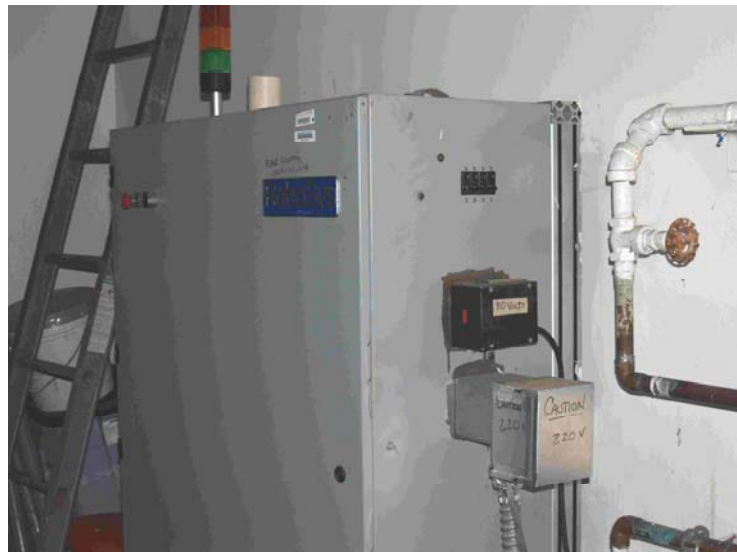
Figure 45 Filter Installation to Suppress Motor-Controller Noise

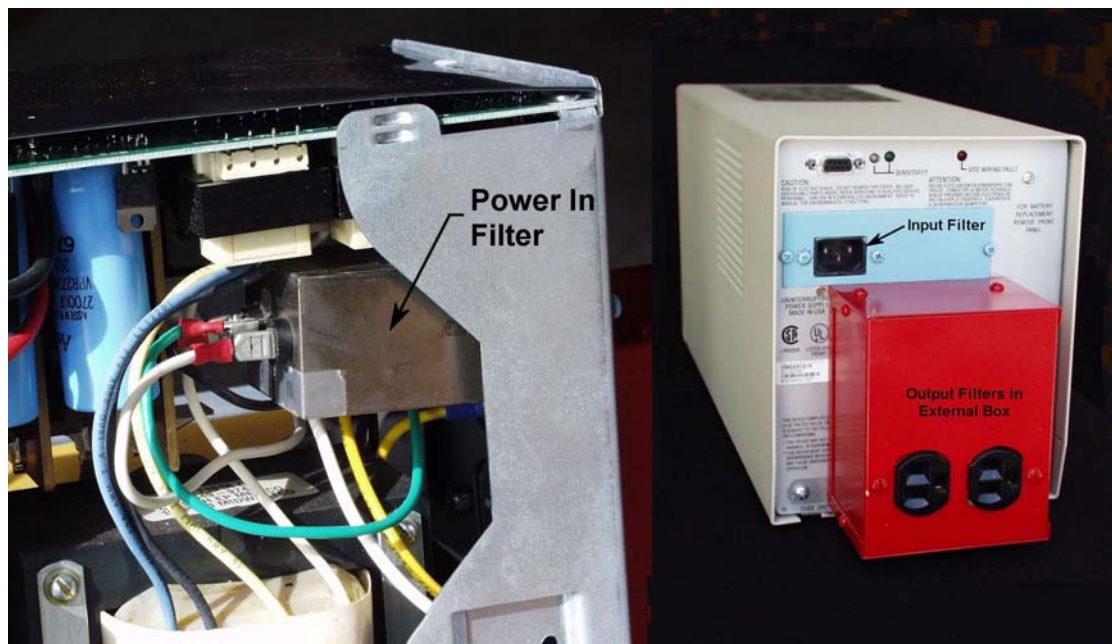
Figure 46 UPS Modified to Comply with BFG Principles

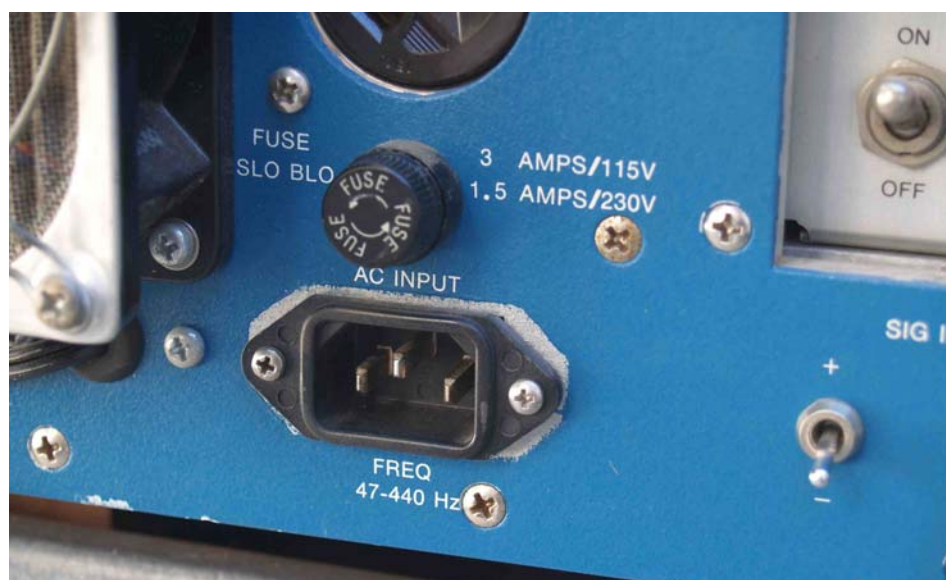
Figure 47 Power Connector that Complies with BFG Principles

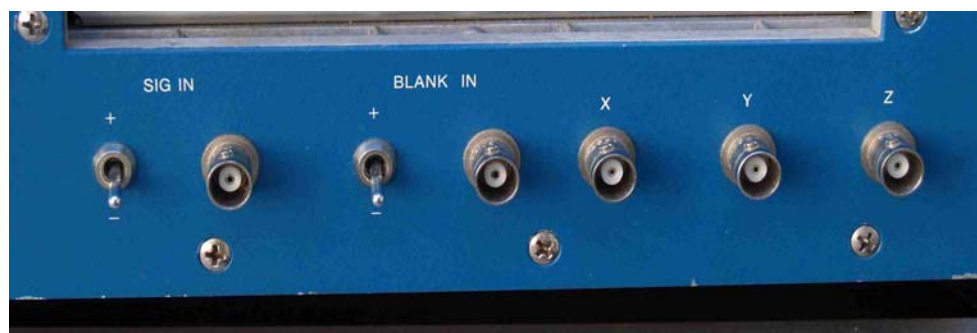
Figure 48 Coax Feed Bulkhead Connectors that Comply with BFG Principles

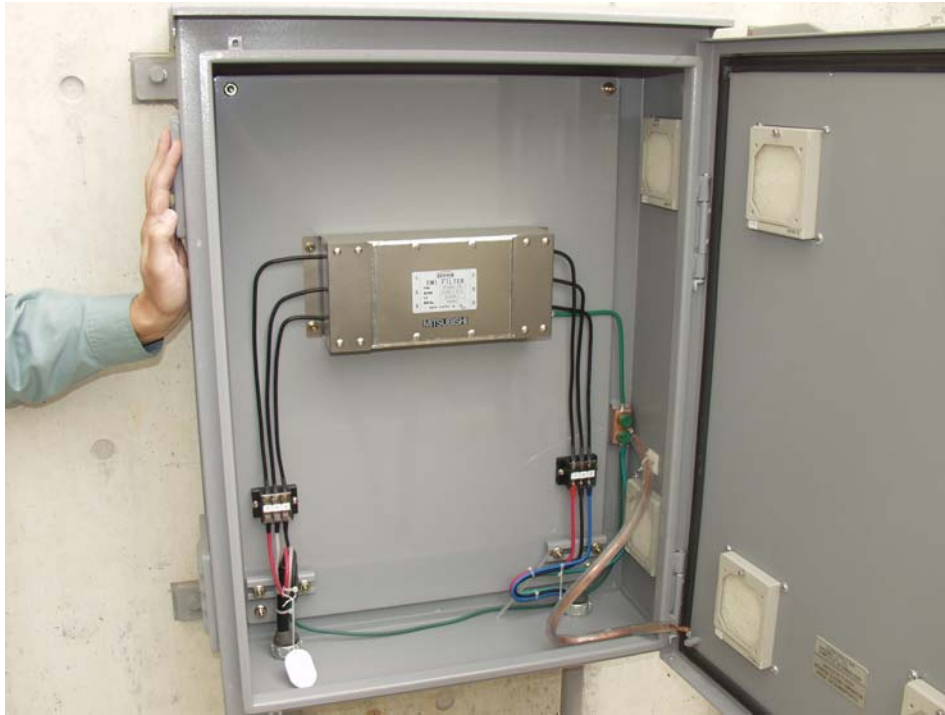
Figure 49 Improper Filter Configuration

Several improper aspects of the filter installation resulted in the total lack of suppression of a severe electromagnetic impulsive noise problem. These aspects were:

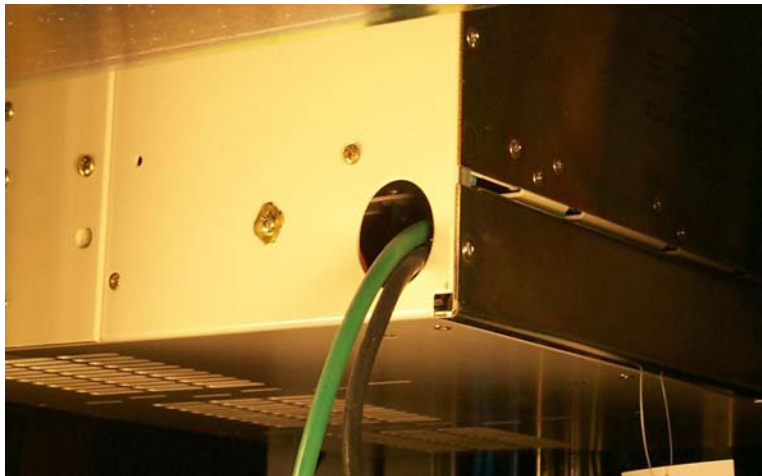
Figure 50 Unfiltered Conductors Exiting a Switching Power Supply

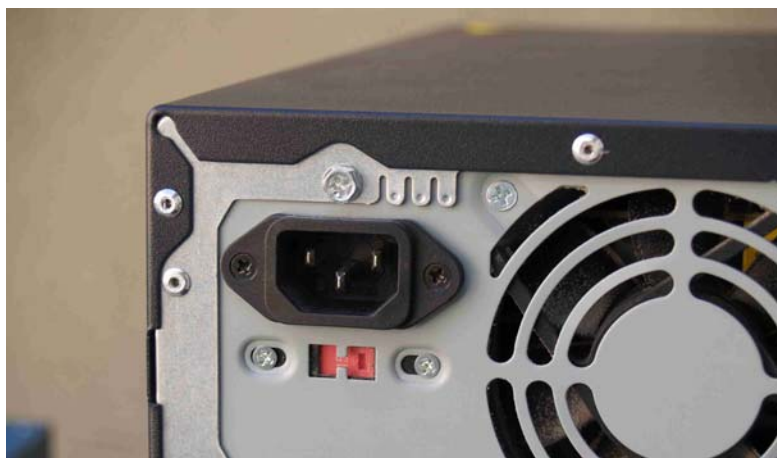
Figure 51 Computer Power Supply not in Accordance with BFG Principles

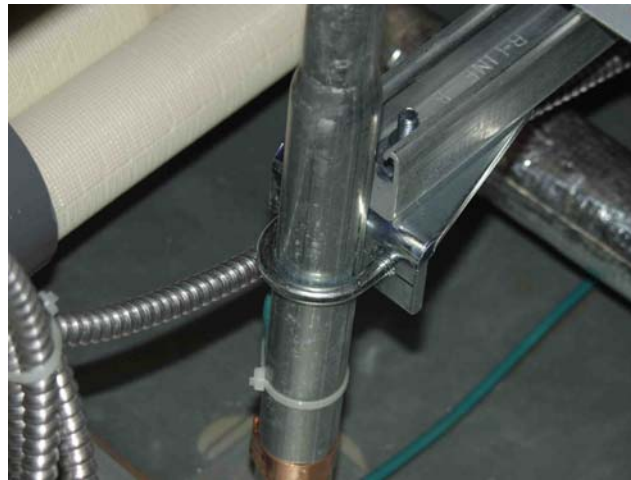
Figure 52 Incidental Contact, Example 1

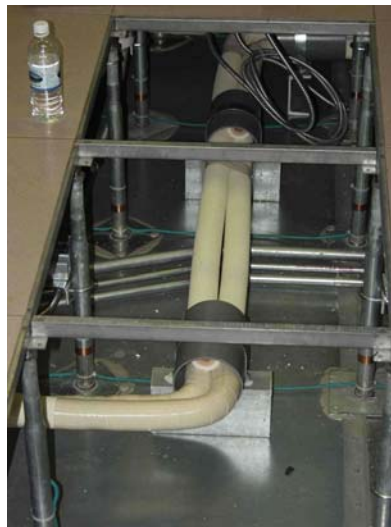
Figure 53 shows another example where a loose coil of BX cable touches other metallic items under a raised floor. Other conductors are supported or bonded to avoid incidental contacts.

Figure 53 Incidental Contact, Example 2

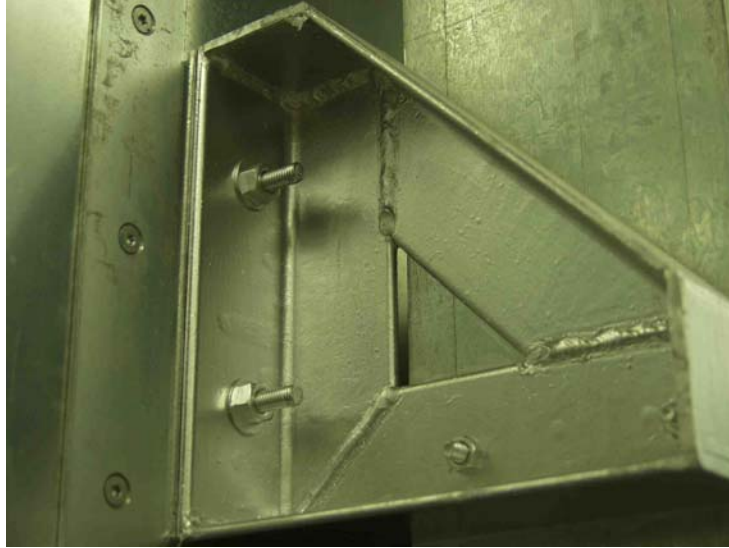
Figure 54 Welds on Galvanized Metal Supports

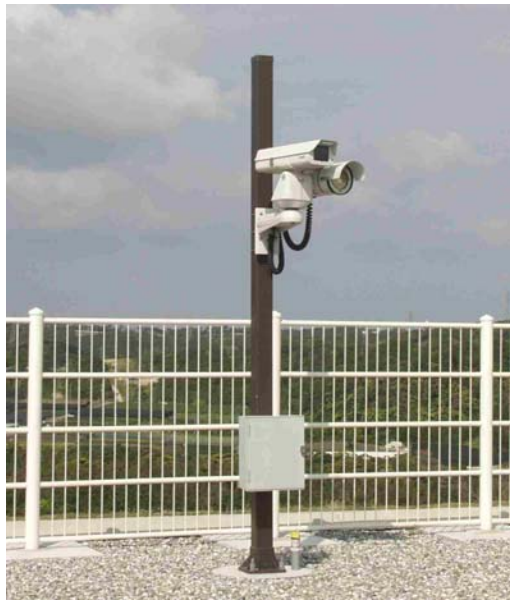
Figure 55 Security Camera Powered by a Noisy Switching Power Supply

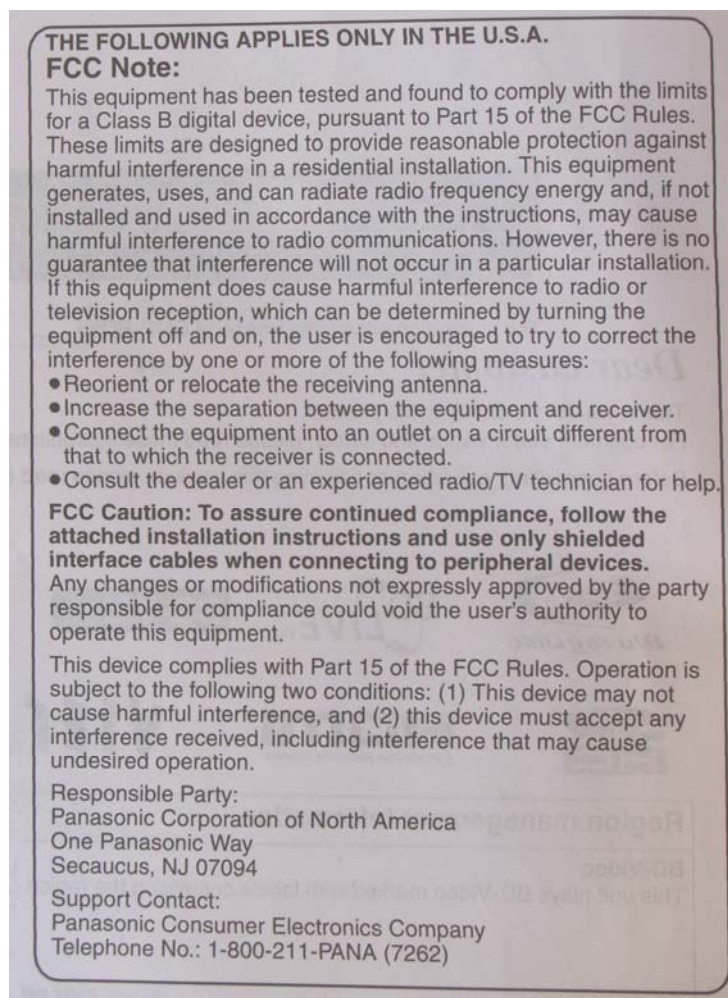
Figure 56 Example of a FCC Class B Label

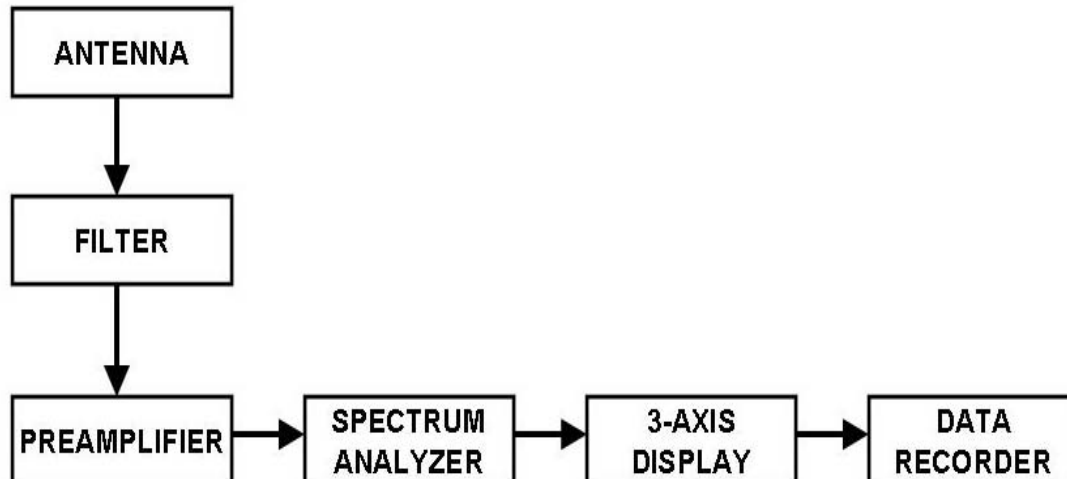
Figure 57 Block Diagram of the Instrumentation

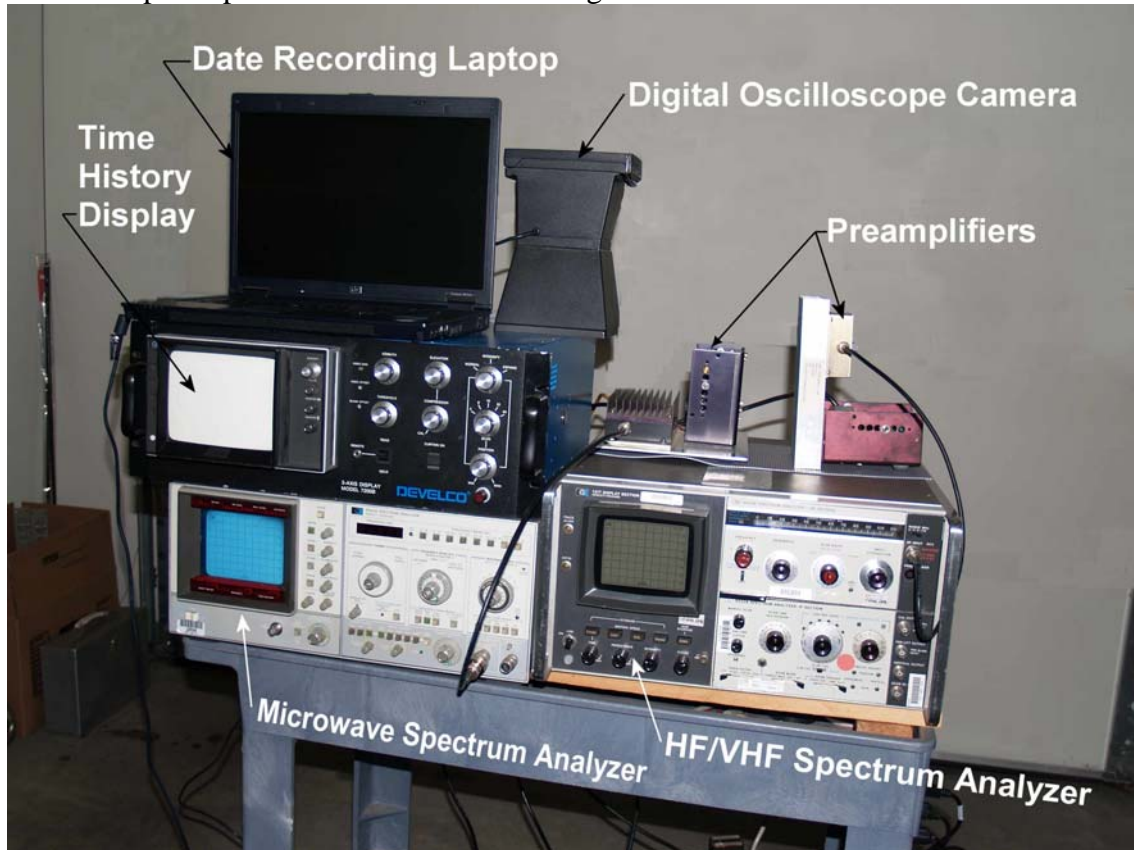
Figure 58 Typical Instrumentation configuration

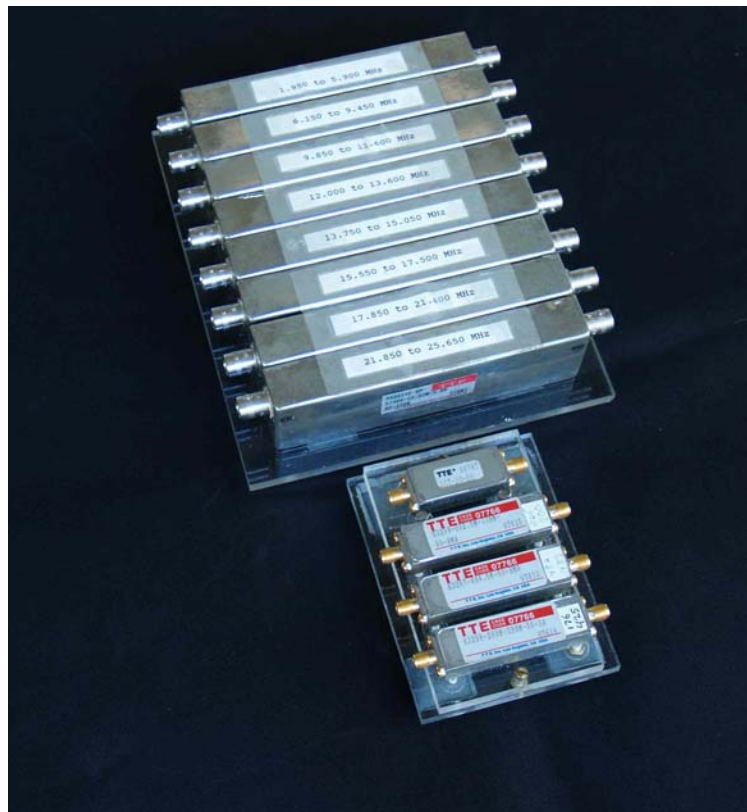
Figure 59 Example of Band-pass Filters

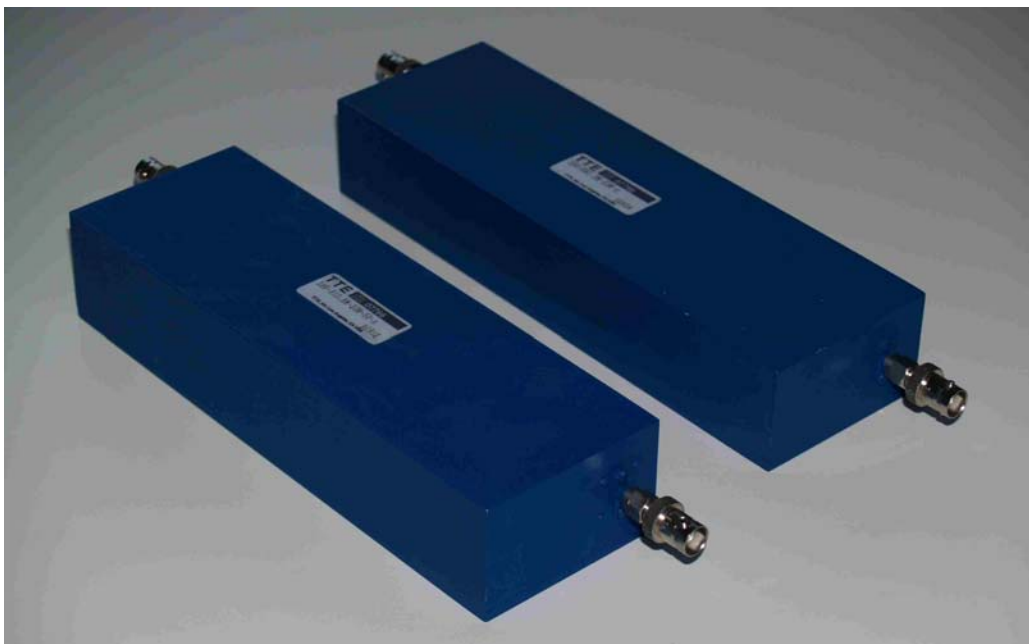
Figure 60 Example of Special Purpose Filters for the UHF Band

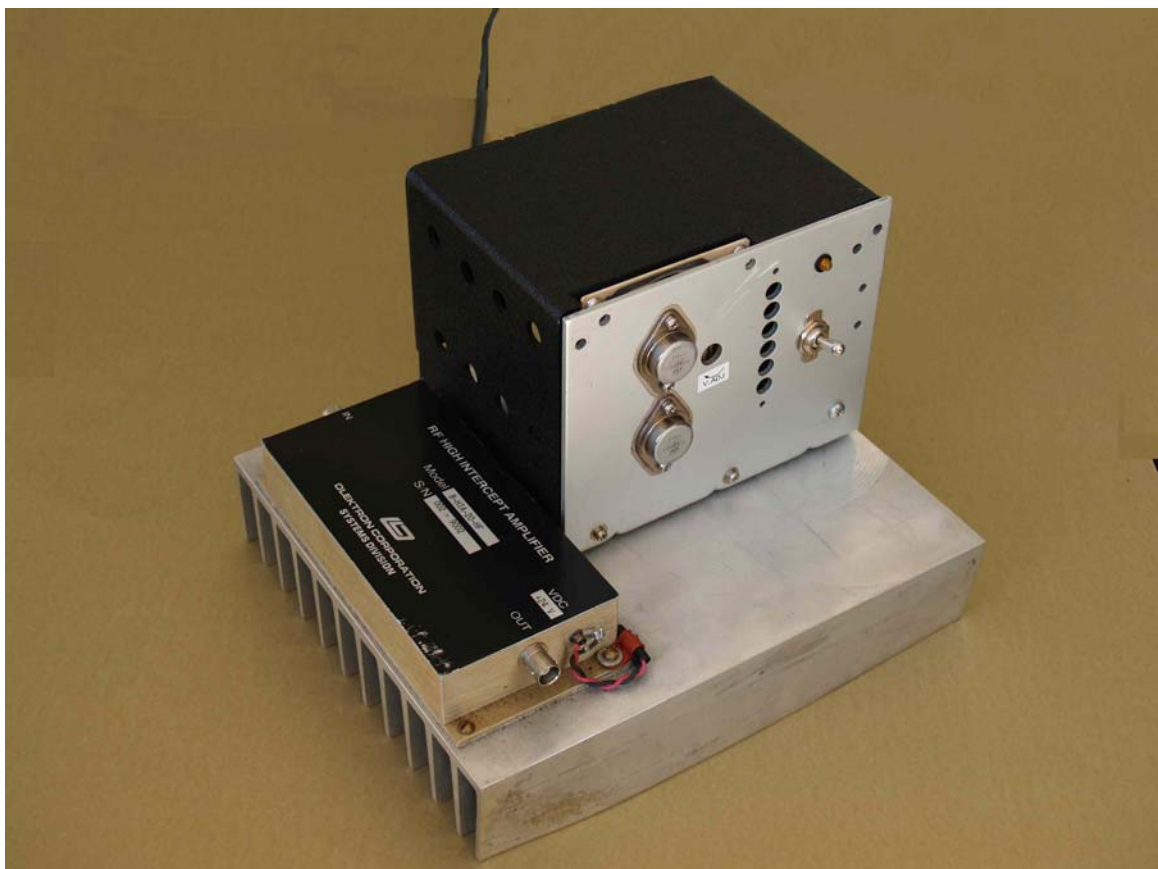
Figure 61 Example of a Preamplifier for the HF Band

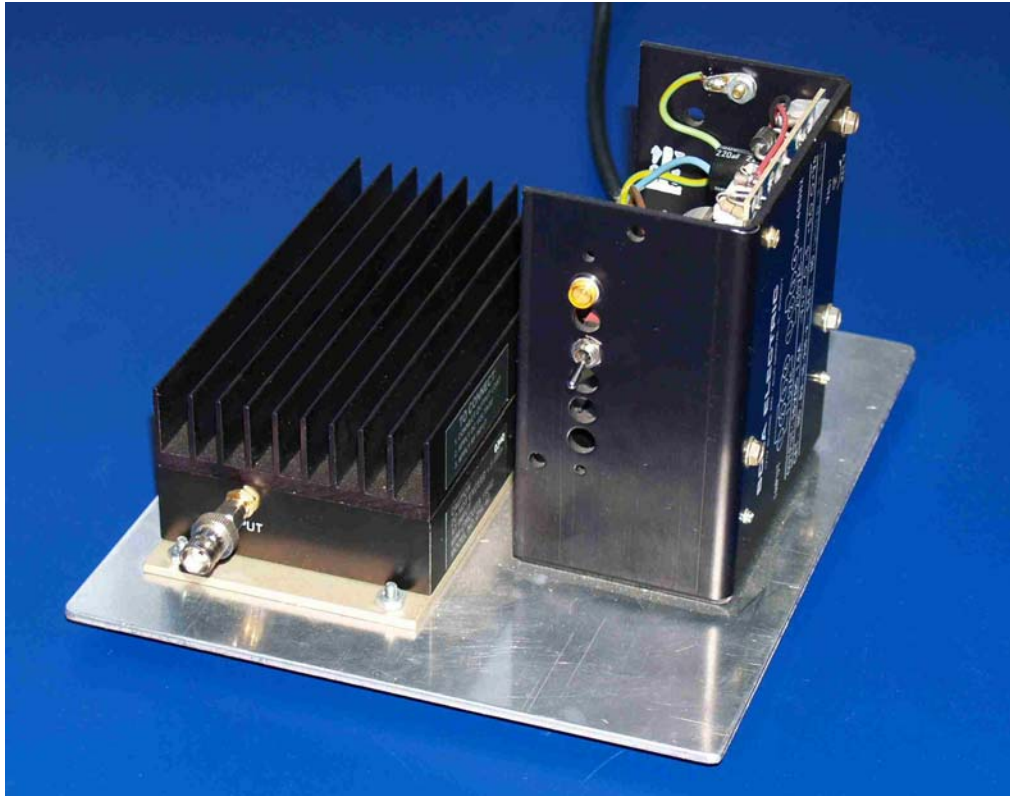
Figure 62 Example of a Preamplifier for the UHF Band

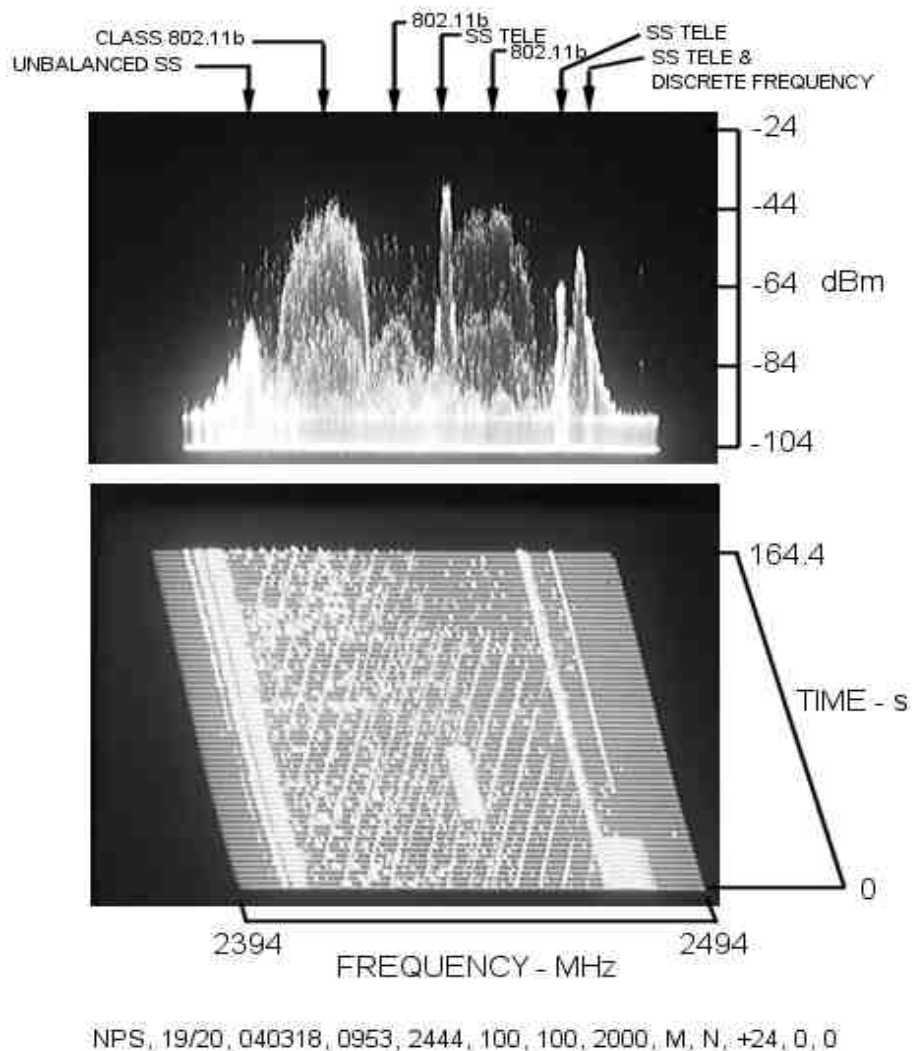
Figure 63 Example of Signals, Noise and Interference in the UHF Band

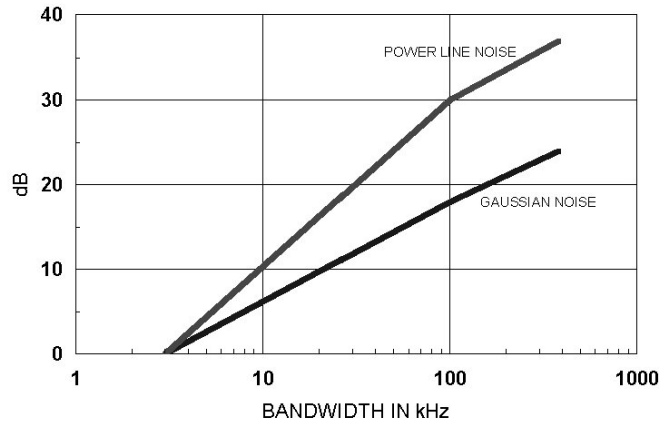
Figure 64 Bandwidth Compensation Plot

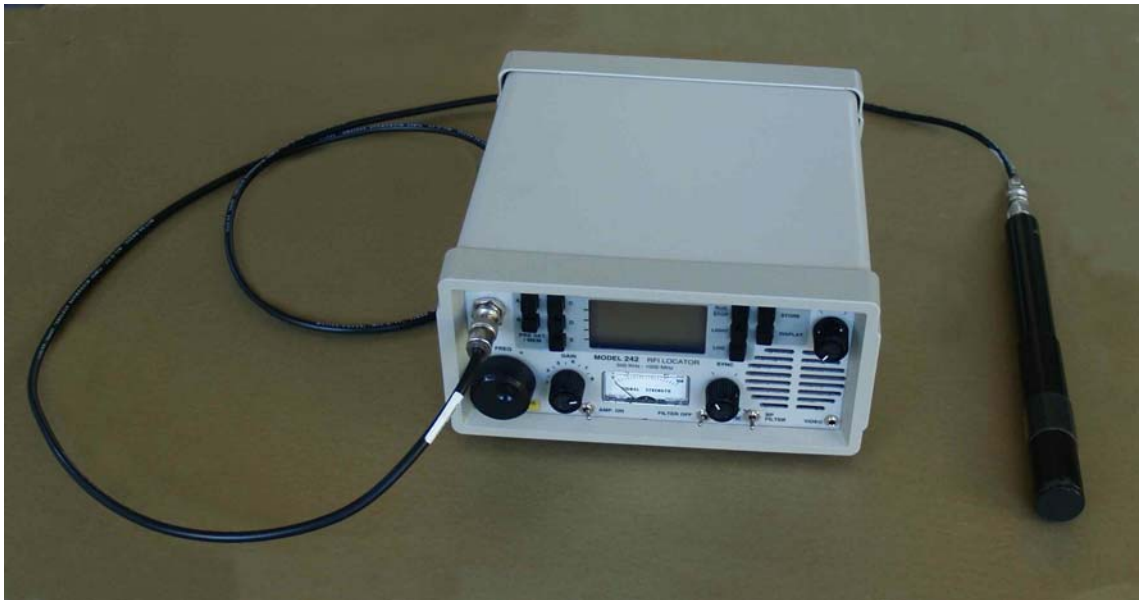
Figure 65 Radar Engineers Noise Receiver with Probe

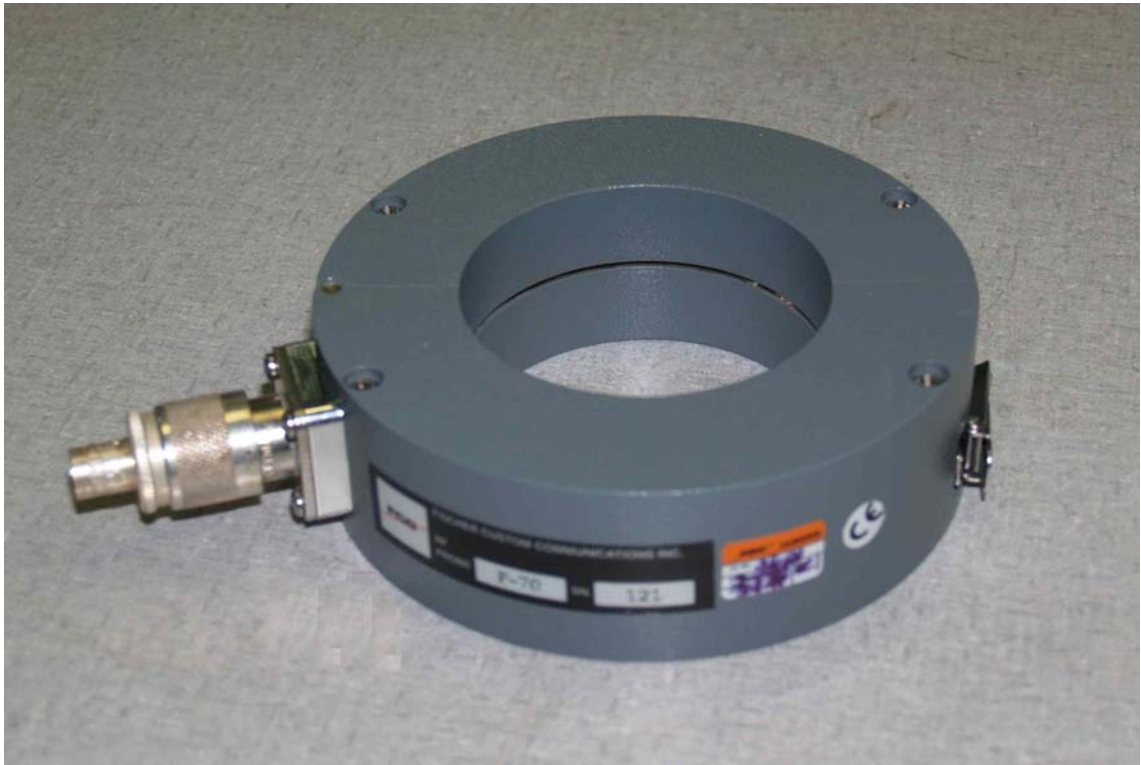
Figure 66 Model F-70 Current Probe

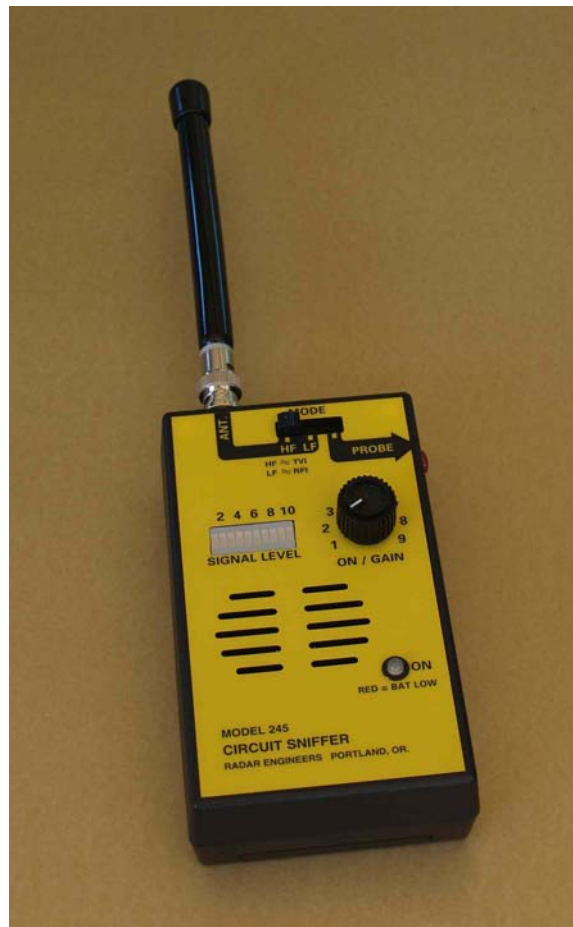
Figure 67 **Circuit Sniffer Used to Locate On-Site Sources**
